Phase I Environmental Site Assessment 1500 Industrial Park Drive, Cornwall, ON

Prepared For:
The Corporation of the City of Cornwall
360 Pitt Street,
P.O. Box 877
Cornwall, Ontario
K6H 5T9

May 2018
EAL Project: 30574

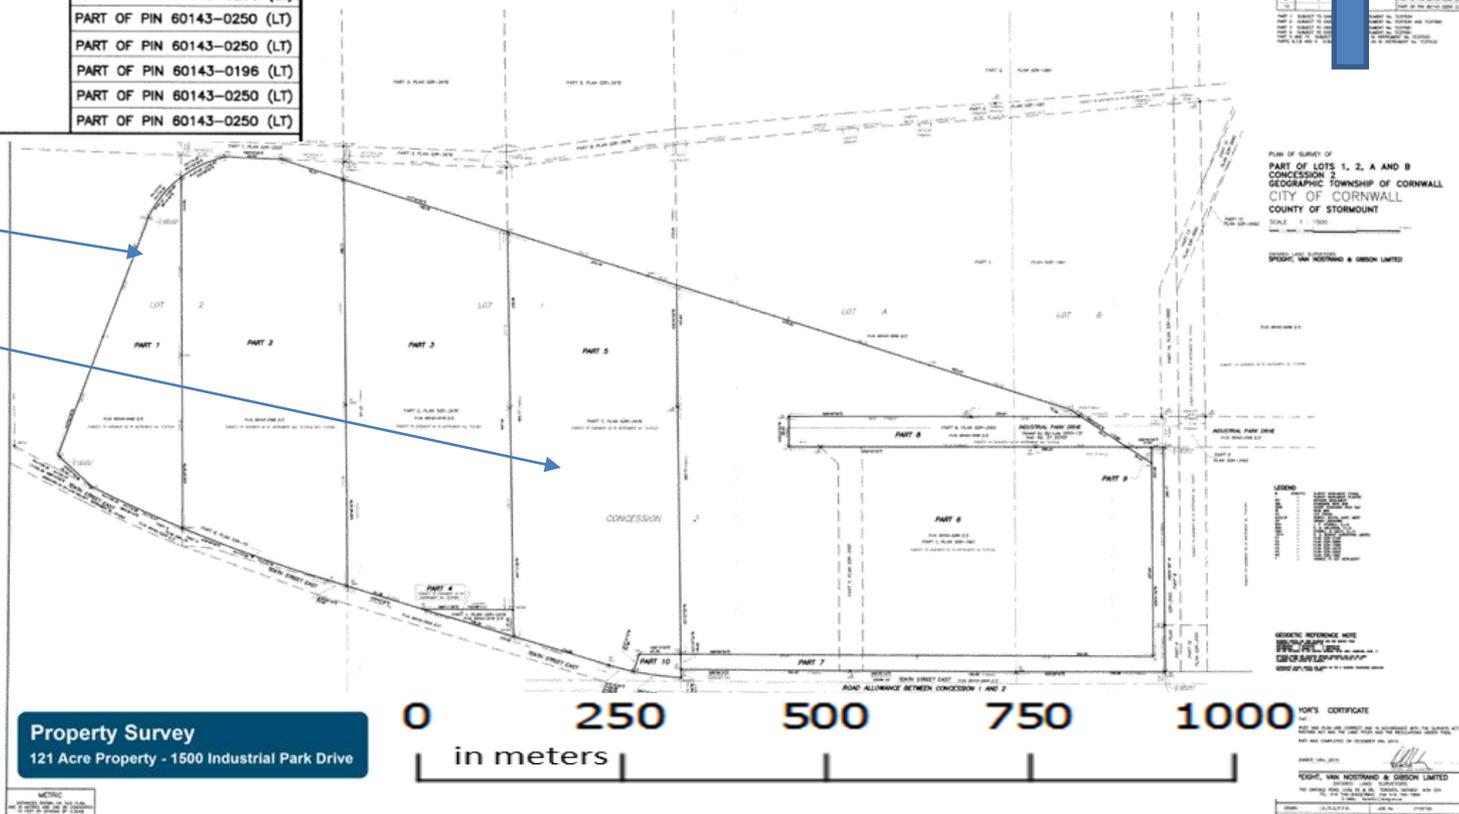
Phase One Property (POP) showing former parcels. Part 5 was formerly part of lands with about 8 to 10 ponds on site.

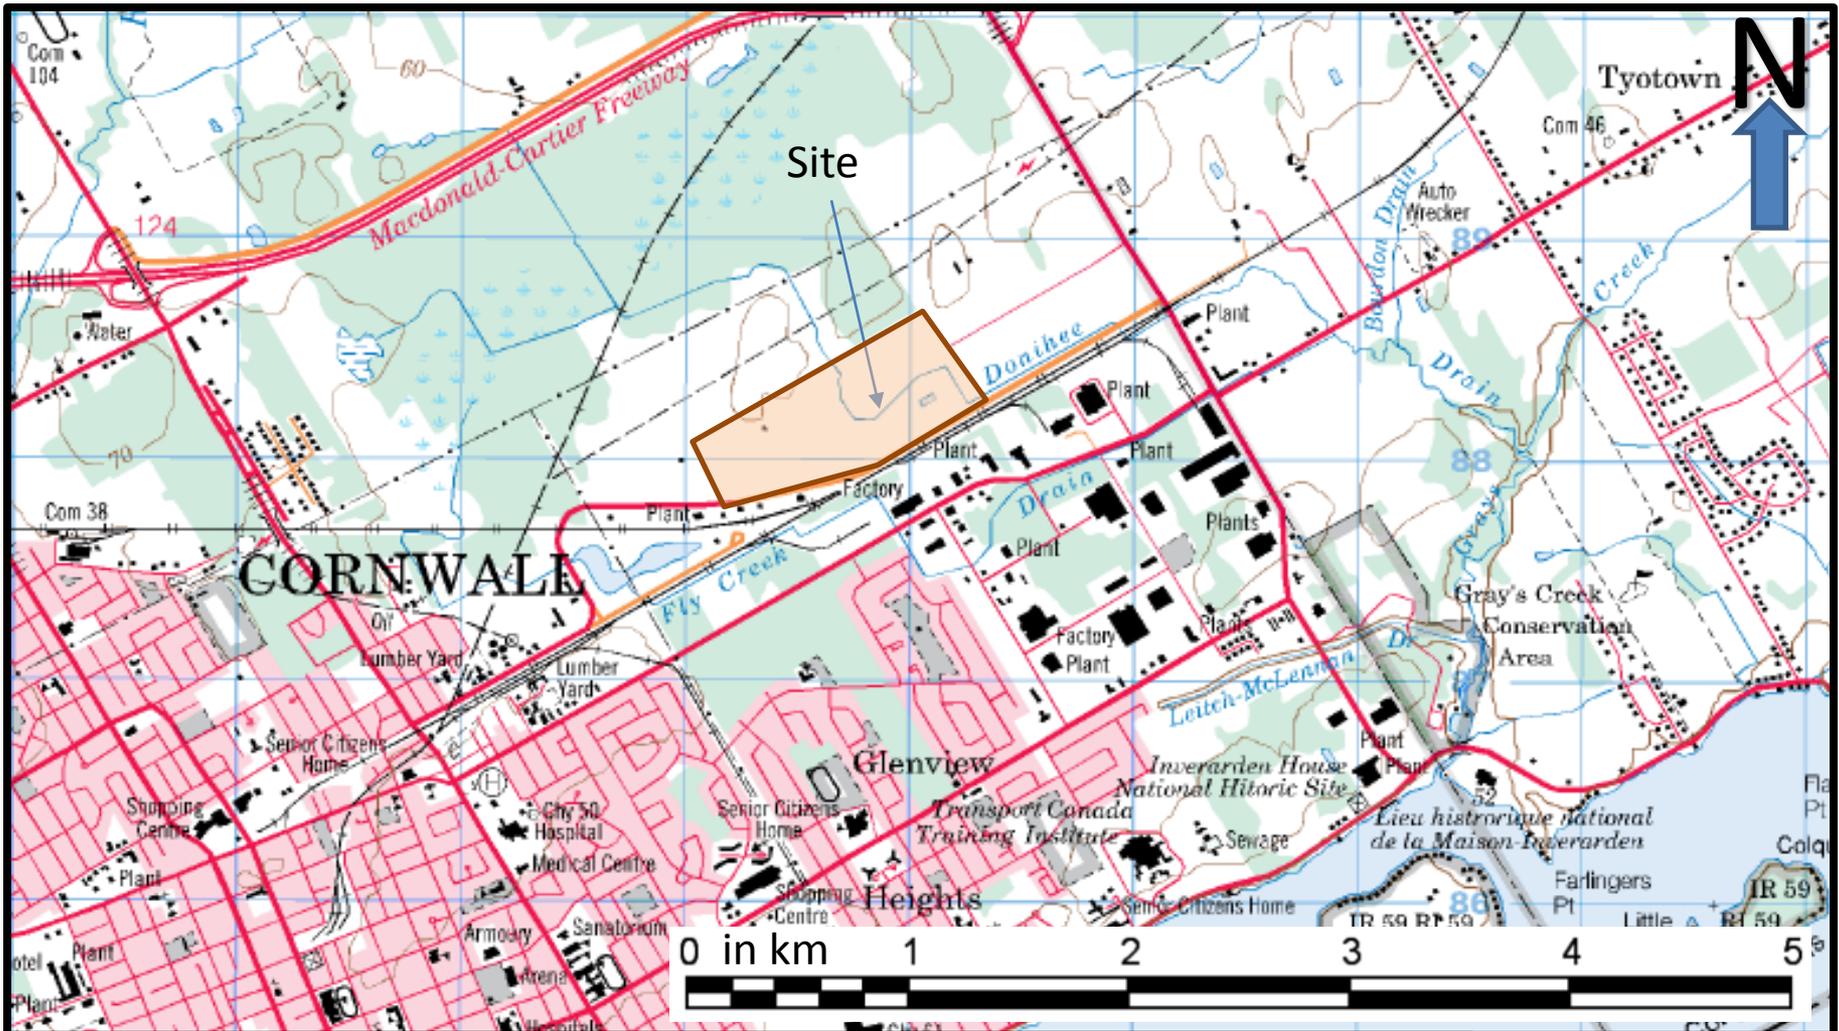
Drawing 3

Swamp and the Donahee Drain, Fly Creek Drain. Note possible farming uses, and rail to north and south. Power Line to north and feeder line to west is shown. Cut Line to north.

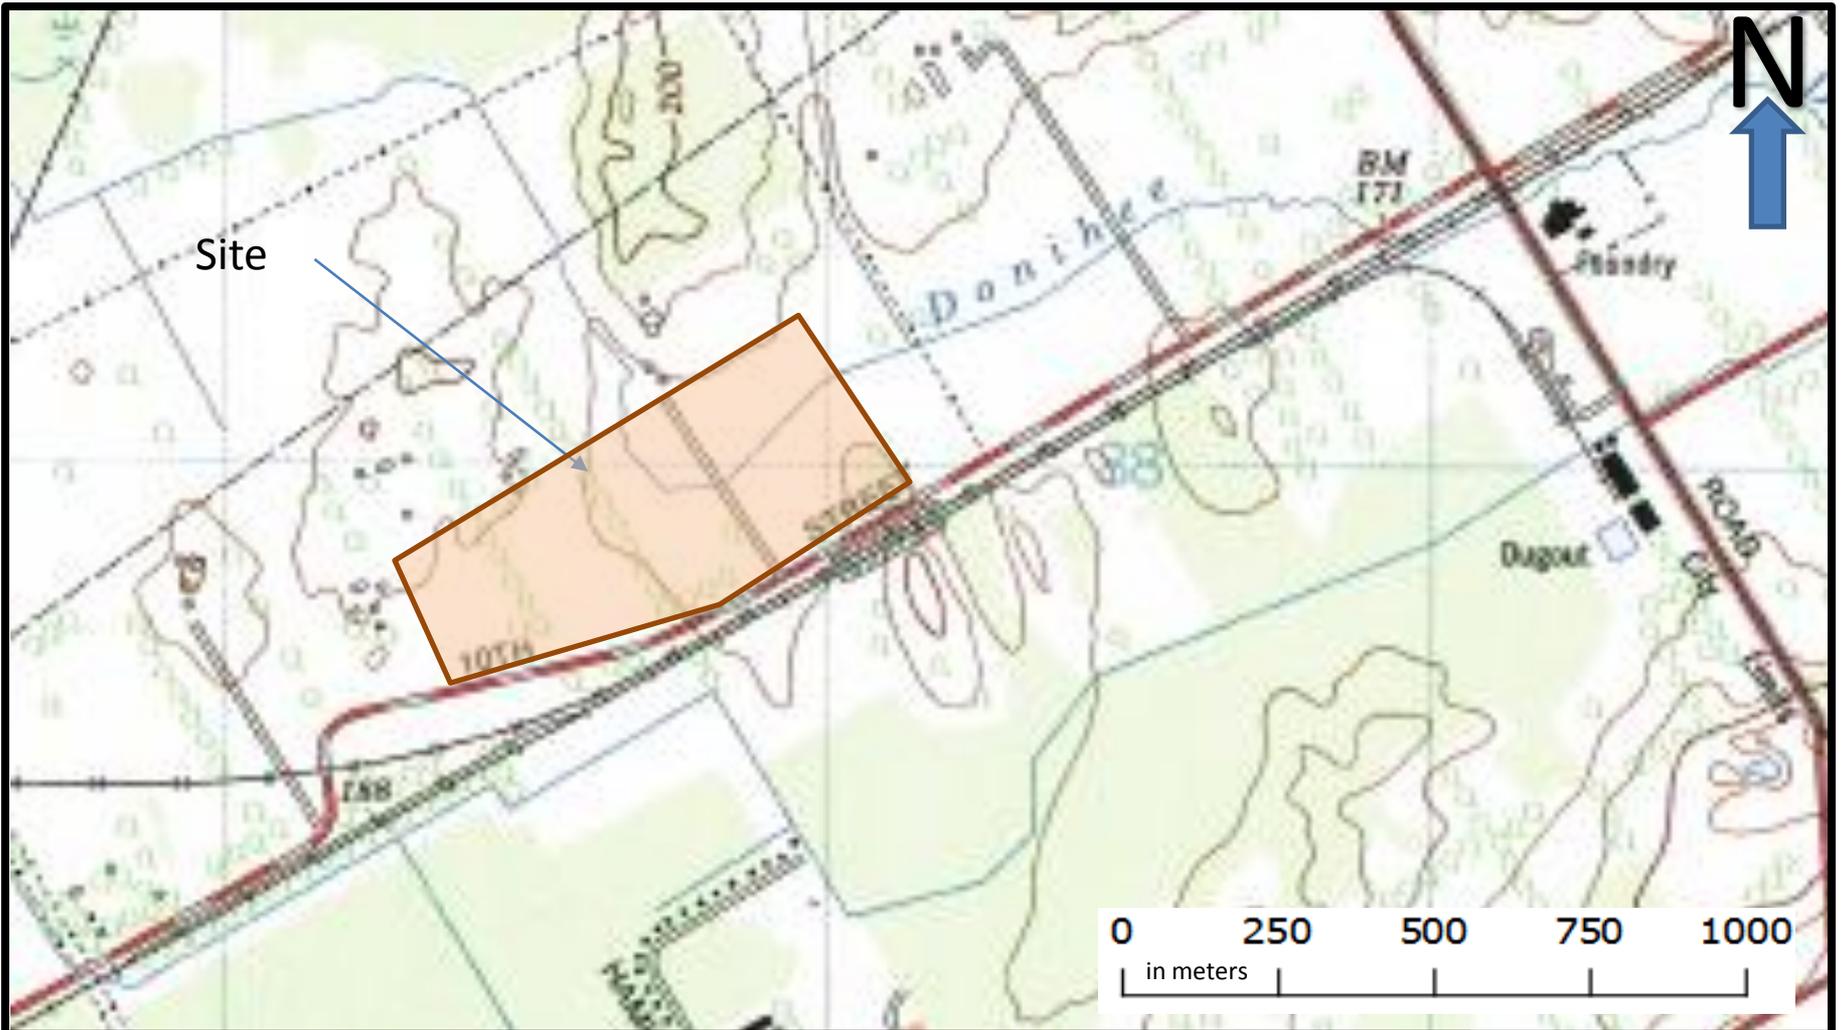
Drawing 4

Note drain through area and nearby low lands. Note ponds in 1980's aerial not present at site.

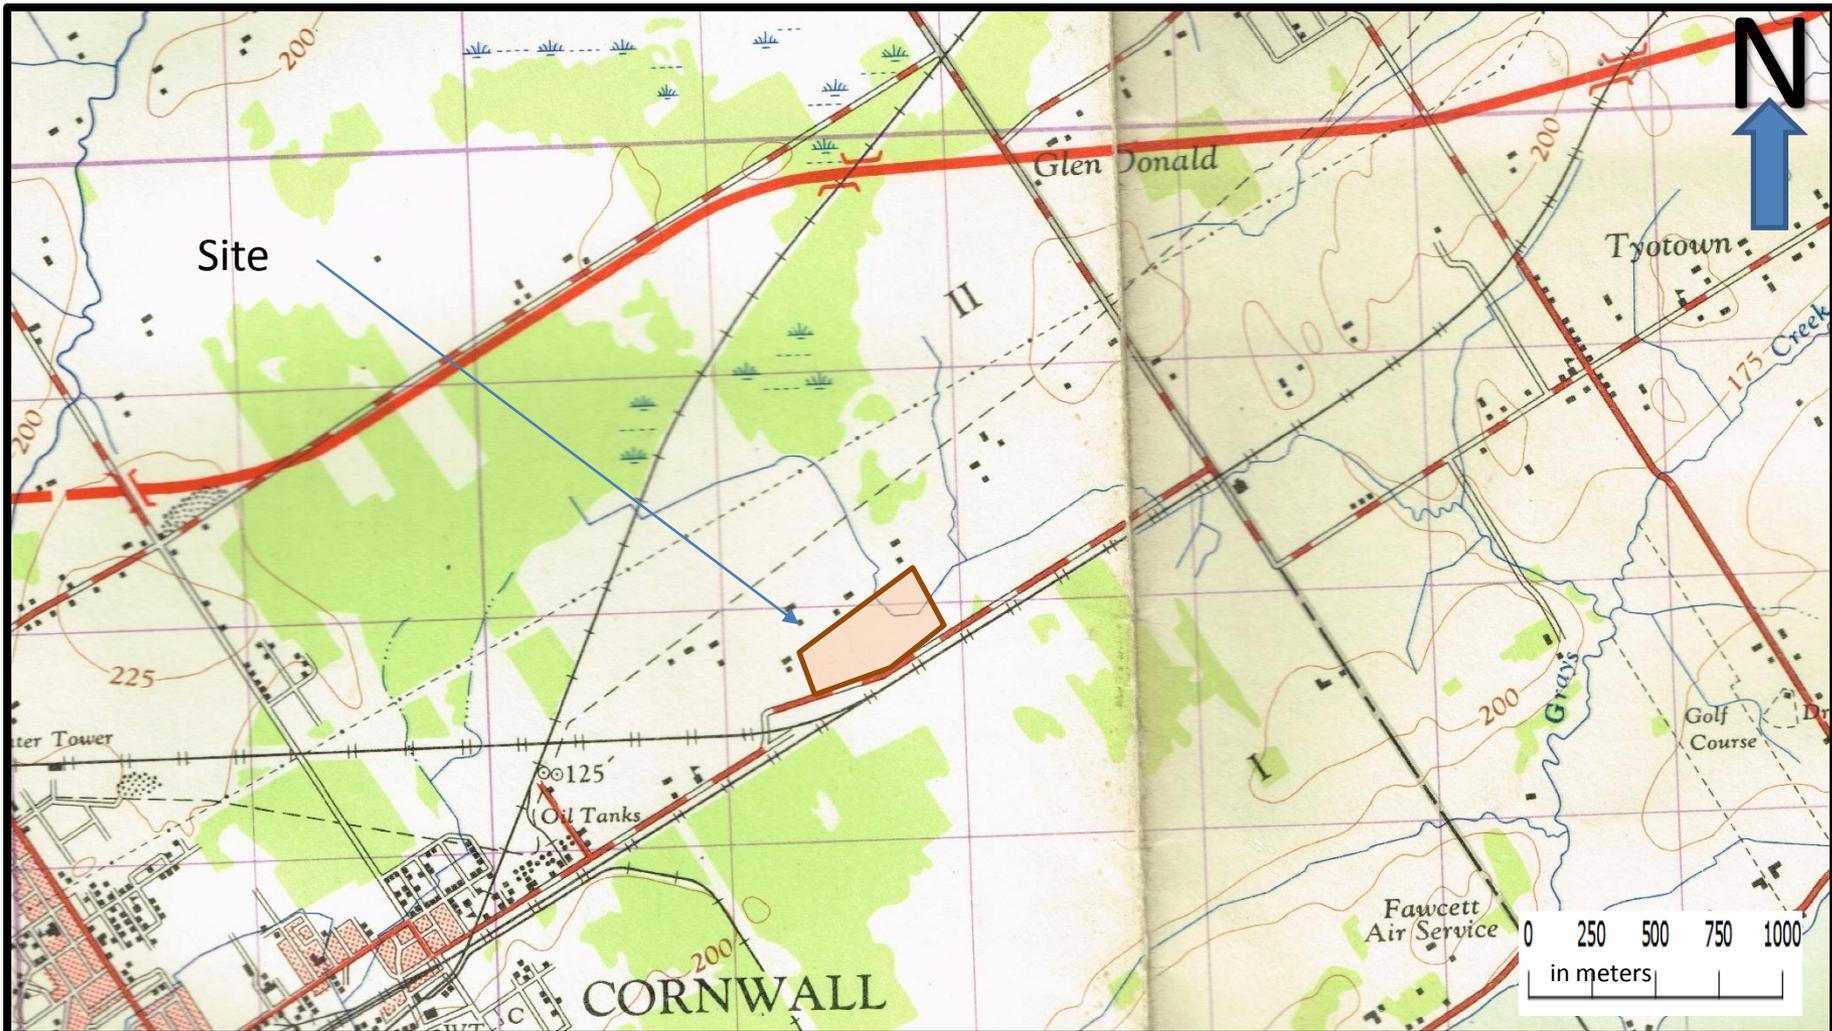
Drawing 5

Note drain through east part of area and nearby low lands. Note ponds in 1980's aerial not present at site. Industrial Park Drive not built. Tenth Street does not go through. Probable arm use. Oil tanks west of site are "far" from site. Power line shown north of site but connector from south in 1937 mapping not shown. A cut line is shown north of site. South of tracks likely farm land. Virginia Drive which Industrial Park is attached to is present.

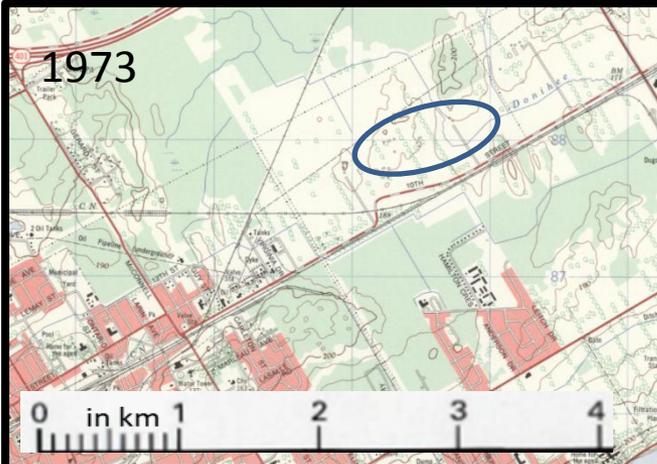
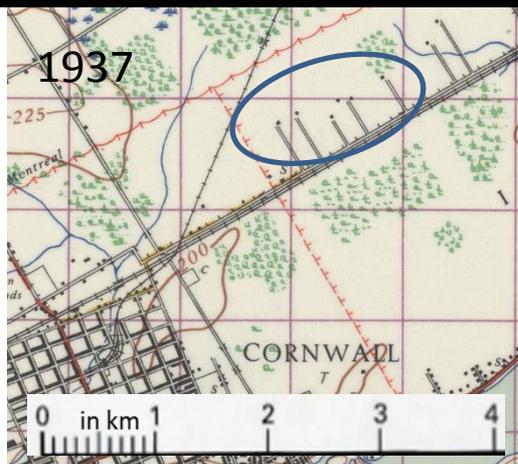
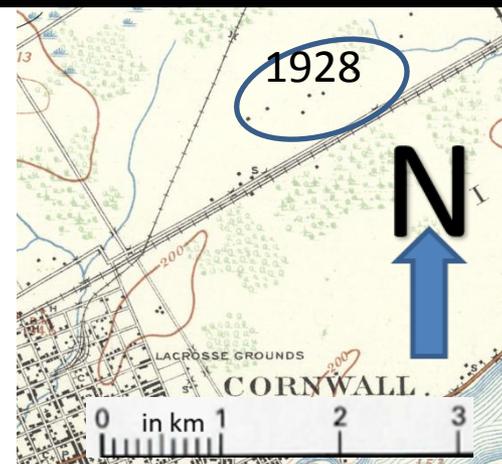
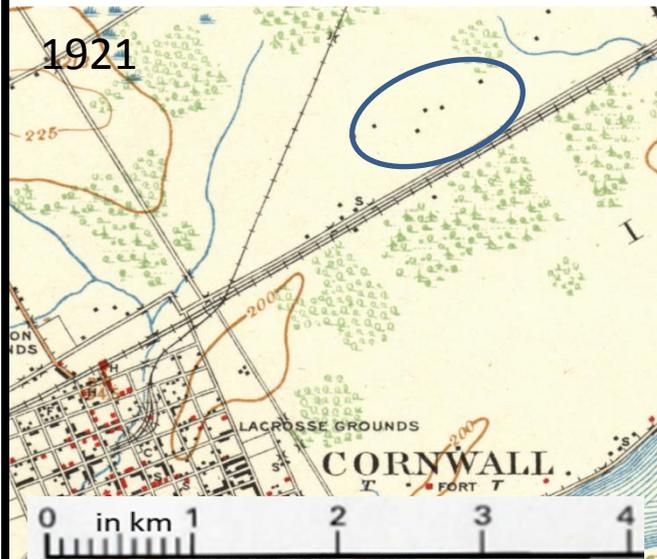
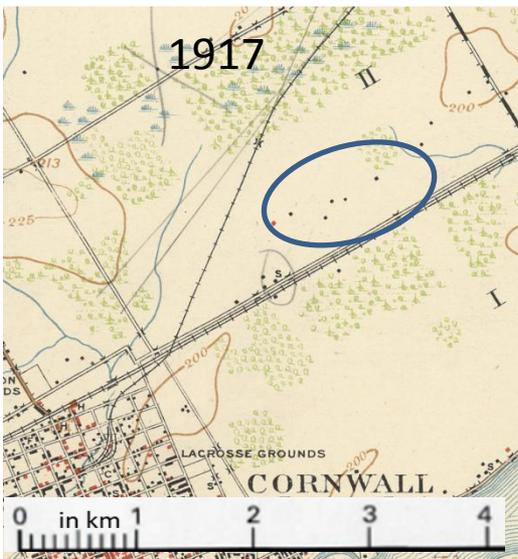
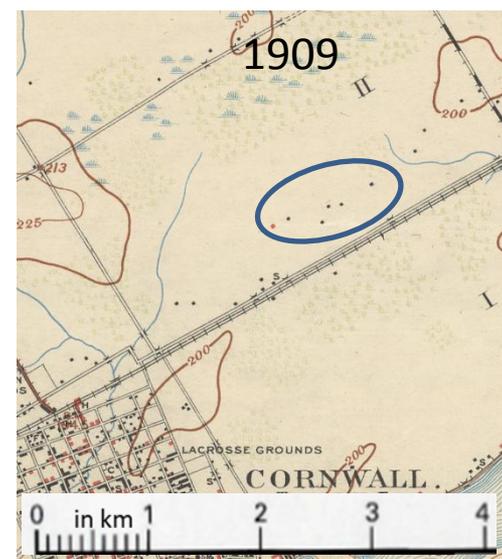
30574
 1500 Industrial Park Driver
 Cornwall, ON
 ON
 Drawing 6

Source: Ontario Topo Preservation Society, NTS 31G/2 (DND and EMR) 1909 to 1973.
 Note : 1909 – Natural Drainage to south west and south east. Rail to north not present. Note ponds in 1980's aerial not present at site. 1917 note rail to north build. Note low area east part of site. 1921 similar to 1917. 1928 similar to 1917. 1937 Note power lines (Montreal Light and Power) , possible orchard, and access lanes shown.. 1973 old farm homes and buildings still shown with no ponds at Part 5 (see Drawing 2).

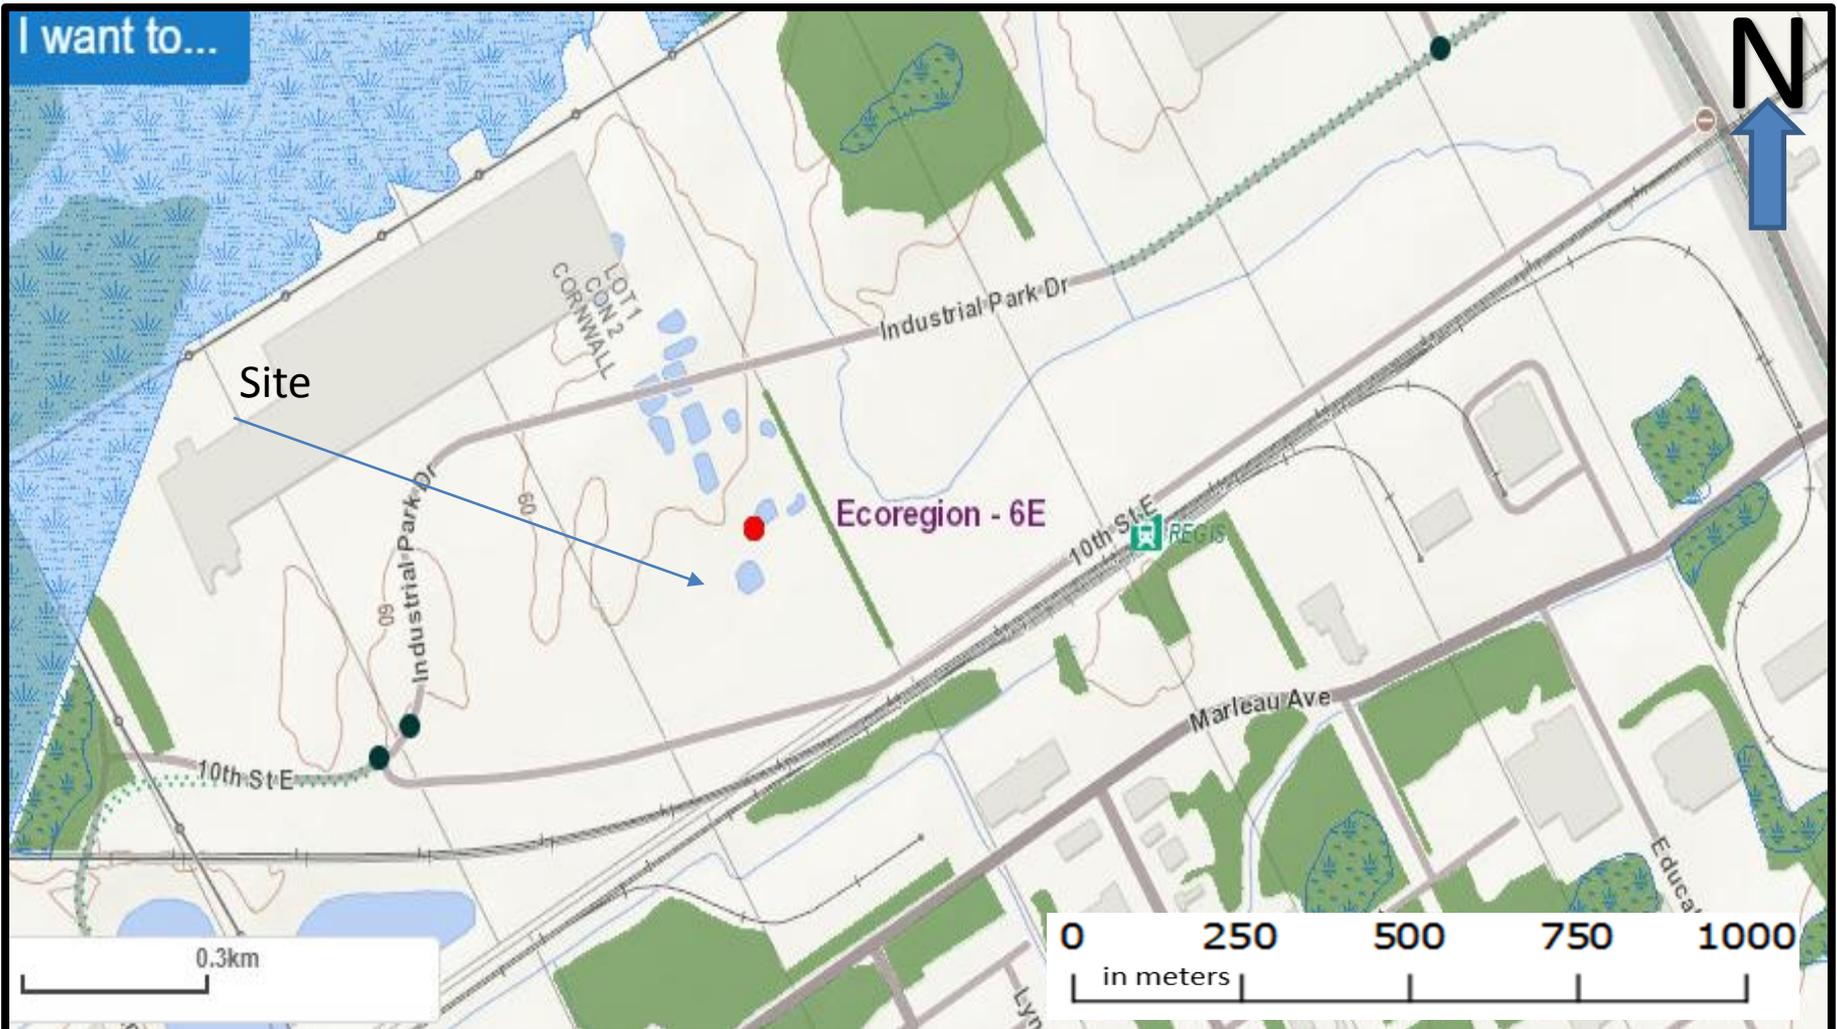
None identified within the POP. Ecoregion- 6E. Slight woodland area throughout middle of the POP. Note numerous ponds on site in this map. This map shows the site was historically at about 60m ASL and the background data likely precedes fill placement The use of these former ponds is not known to EAL.

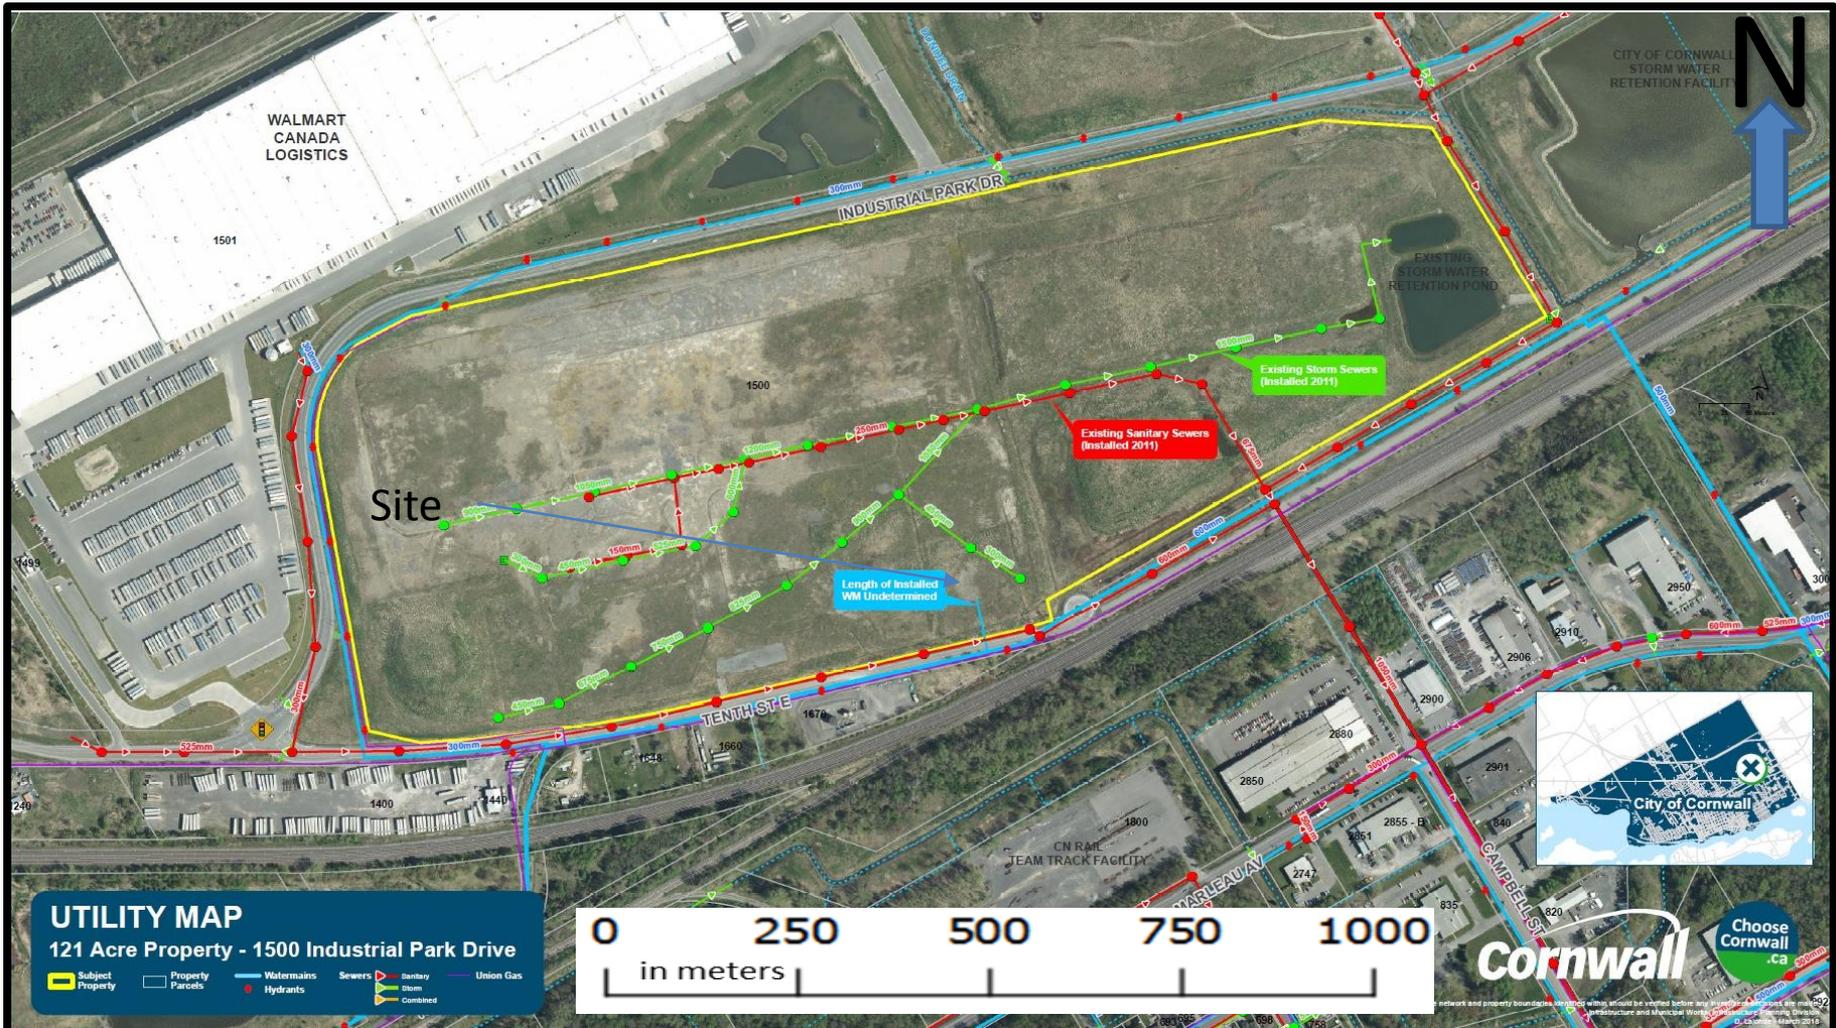
Drawing 9

Phase One Property (POP) location. Note existing utilities in 2011. The utility trenches likely intersect the former natural drainage channels or the Donihee Drain. Note storm water ponds on Site.
Sediment quality unknown in Storm Pond.

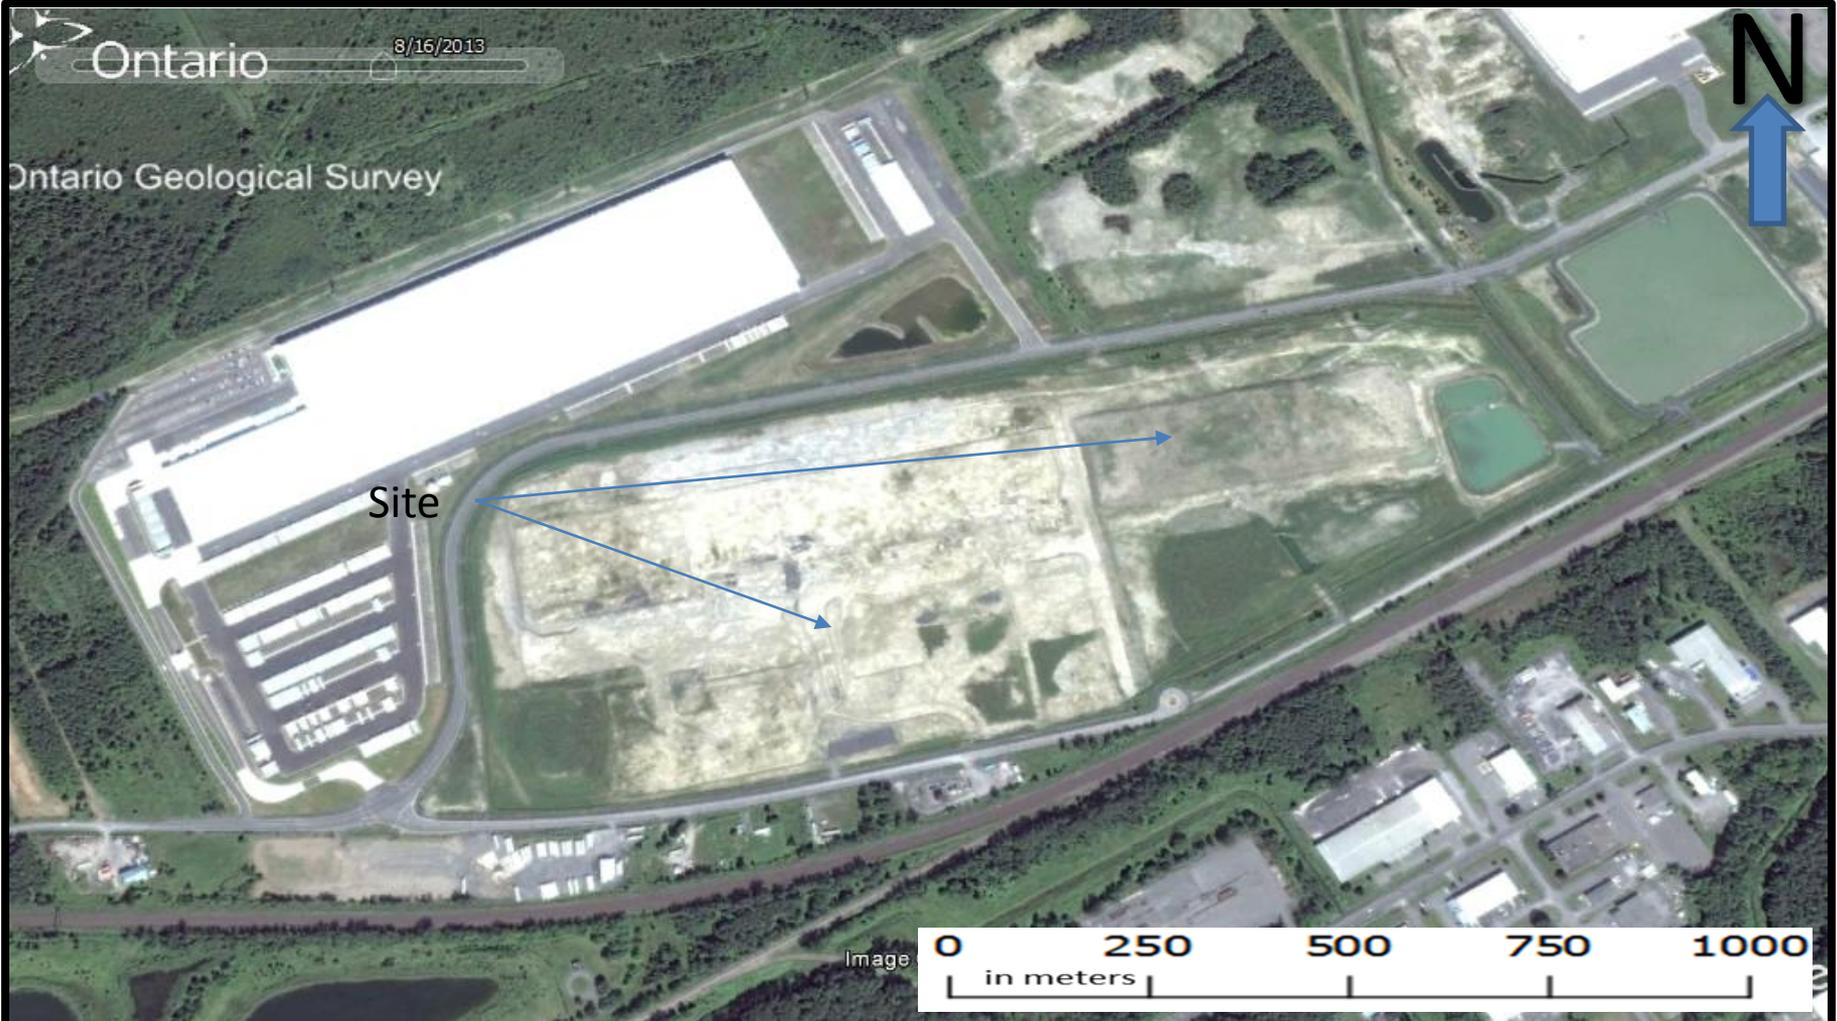
Drawing 12

Site to the northwest adjacent to the POP, developed as a Wal-Mart Warehouse and POP has all houses removed and a drain to the east; one on Site and one directly east of the Site (Donihee). The POP is in Phase 1 for construction, fill may have been placed on Site. Petro Pass Truck Stop is to the northeast and a commercial truck repair is also to the northeast of the POP. Gymnastics club to the east.

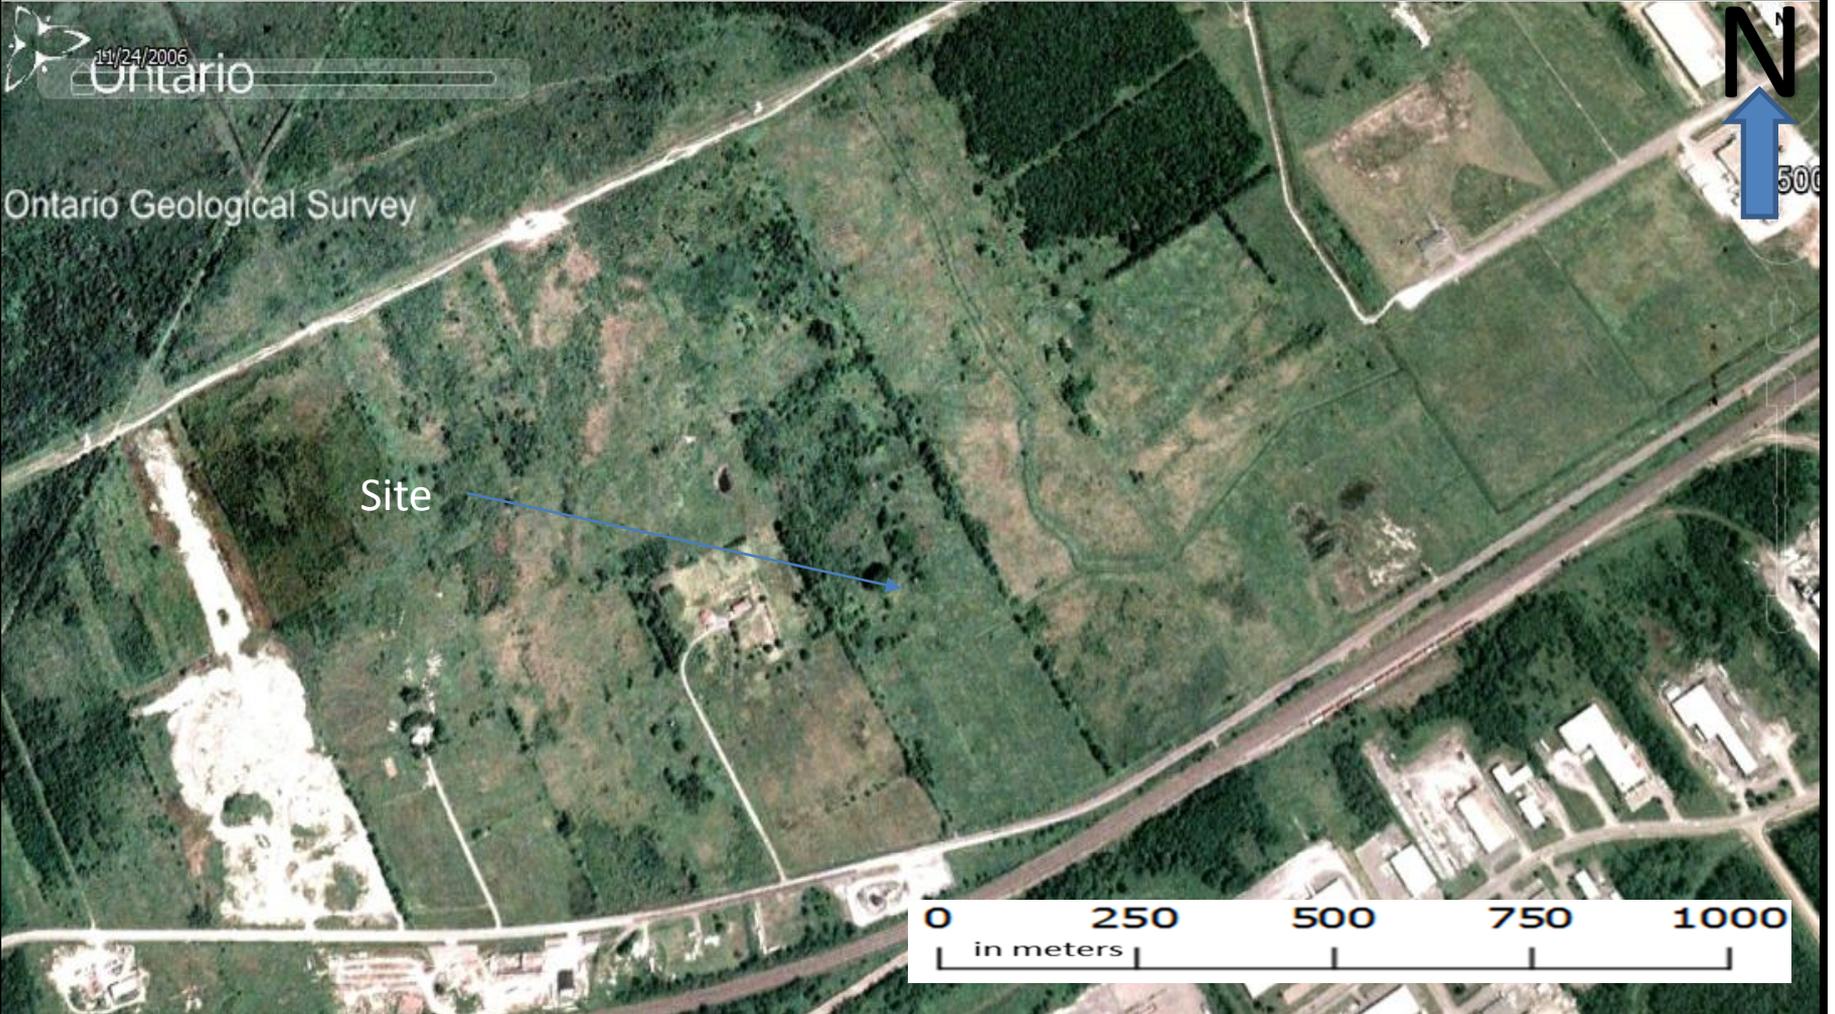
Drawing 16

Ponds from 1986 gone from Site, drain and residences/farms still on Site. New developments to the south both north and south of the rail and to the east of the Site; commercial/industrial. Fly Creek Drain to the south of the rail tracks.

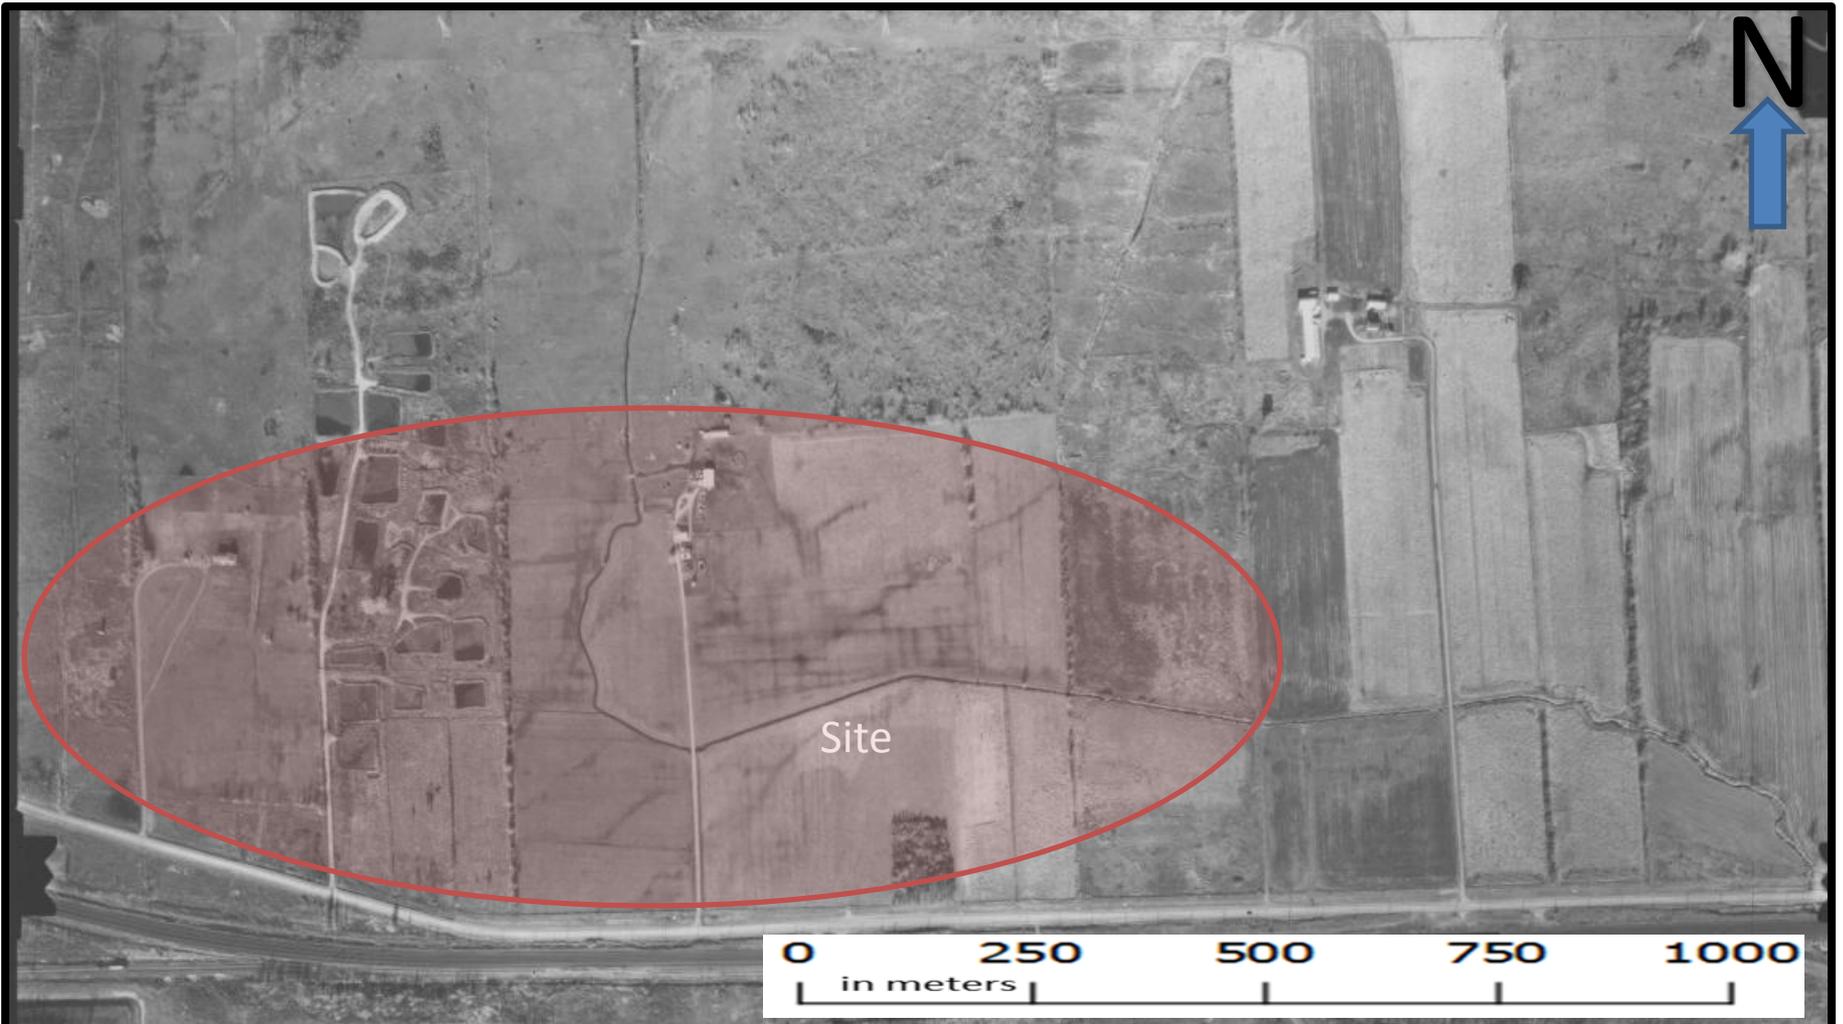
Rail to the south, drain through the Site. Farms and residences throughout the Site. Ponds to the west on the Site use unknown at present by EAL. Orchard bottom southeast corner of Site. Note numerous ponds on Parcel 5.

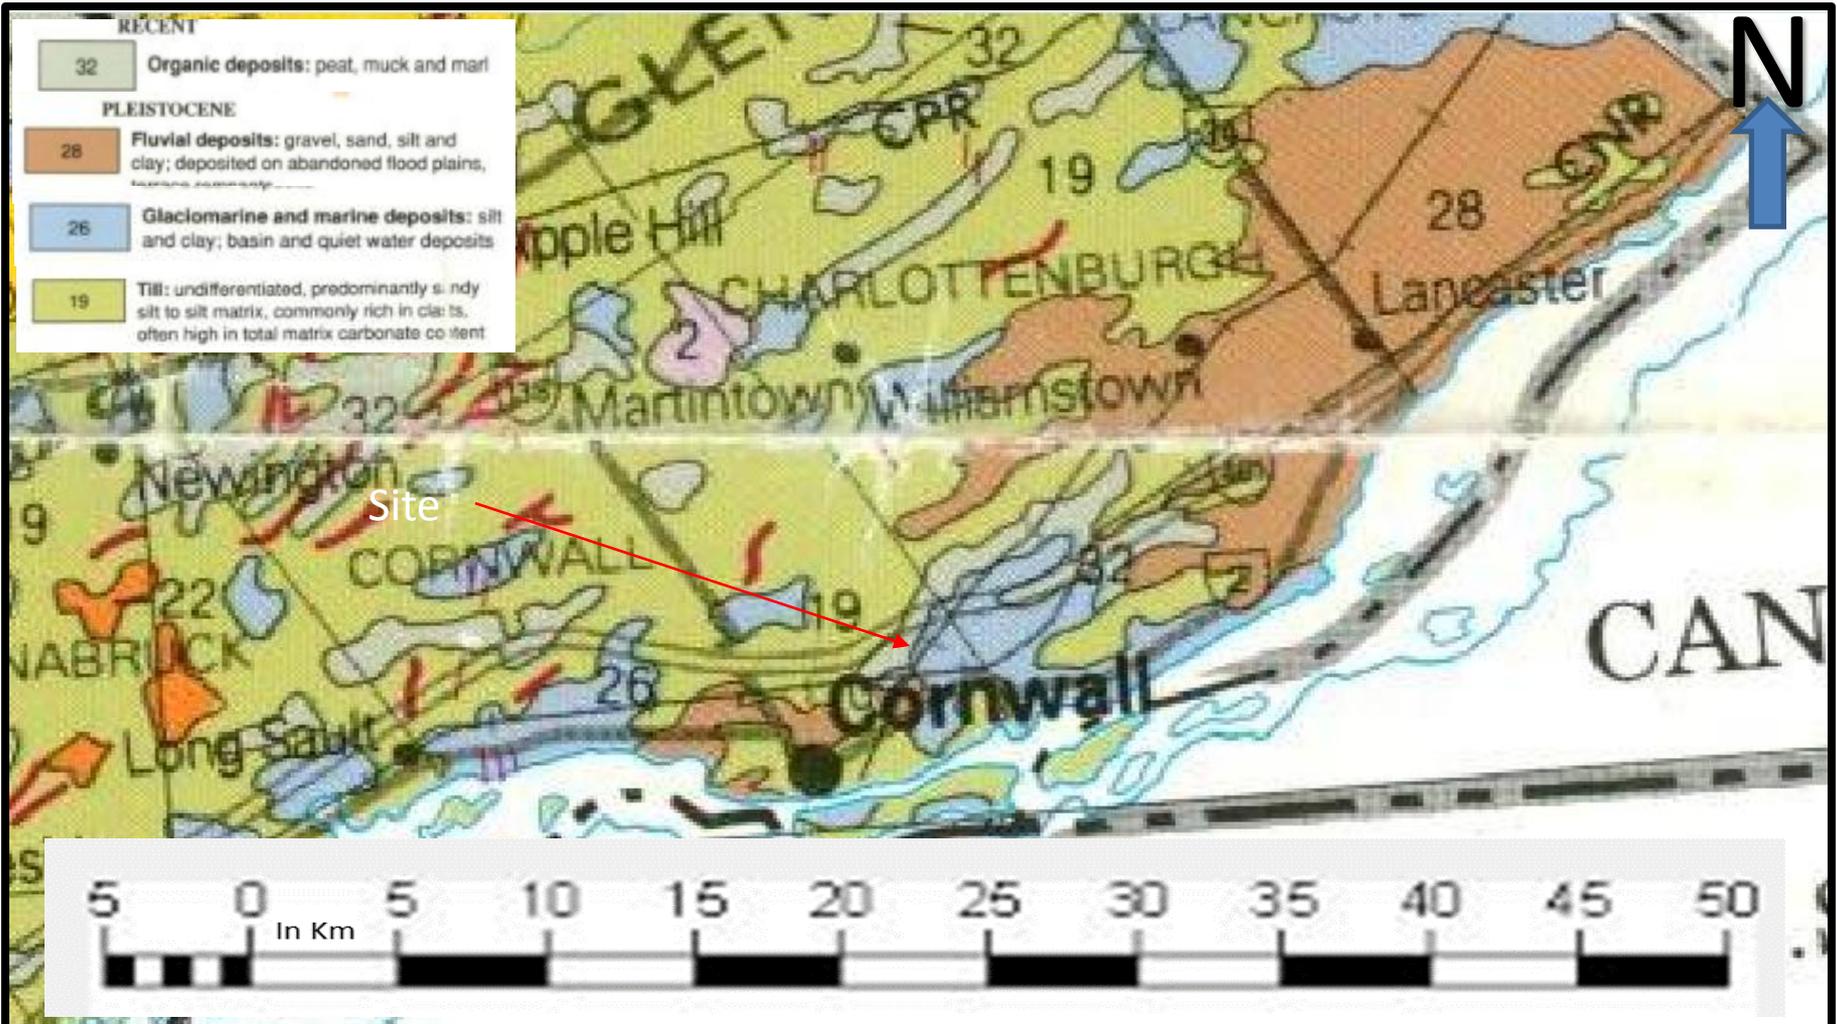
Drawing 22

The Site sits within Glaciomarine and marine deposits of silt and clay, but also fluvial deposits of gravel sand and silt clay and organic deposits may be found. Surrounded by undifferentiated Till; predominantly sandy silt to silt.

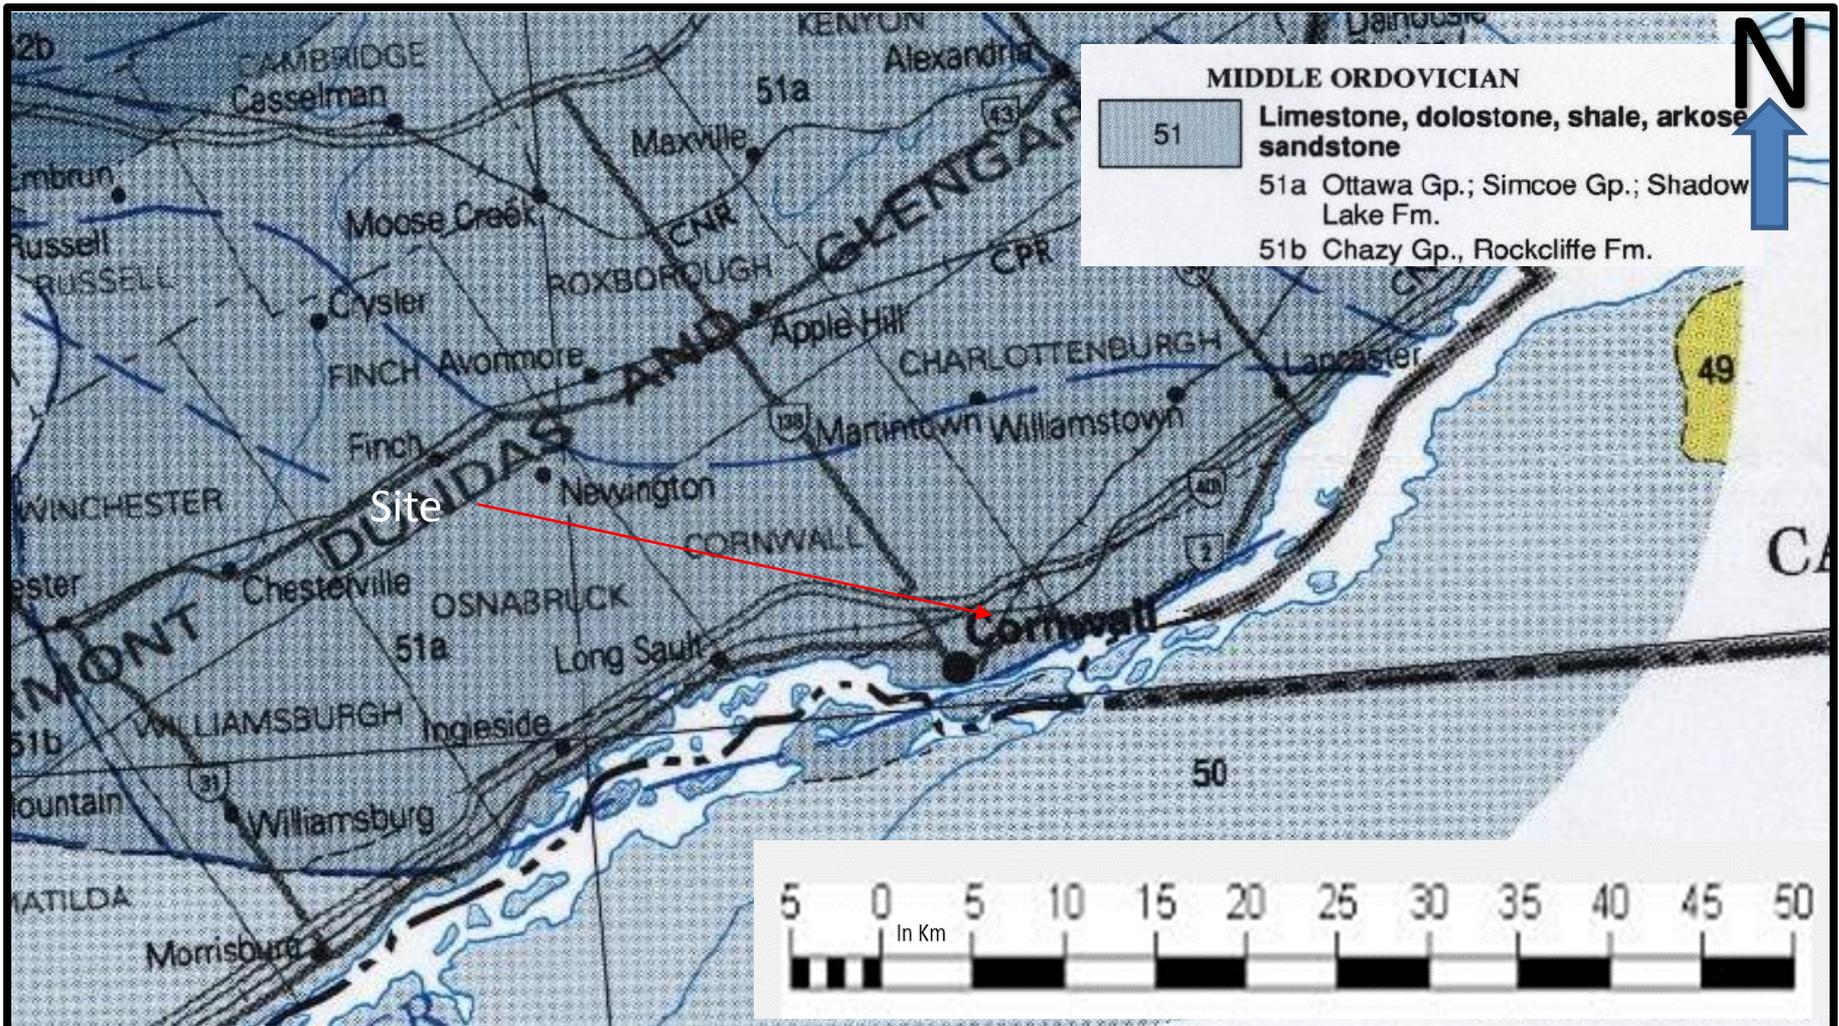
Drawing 23

The Site consists of the Ottawa Group, Simcoe Group and Shadow Lake Formation, which consists of; limestone, dolostone, shale, arkose and sandstone.
