Phase I Environmental Site Assessment 1500 Industrial Park Drive, Cornwall, ON

Prepared For:
The Corporation of the City of Cornwall
360 Pitt Street,
P.O. Box 877
Cornwall, Ontario
K6H 5T9

May 2018
EAL Project: 30574

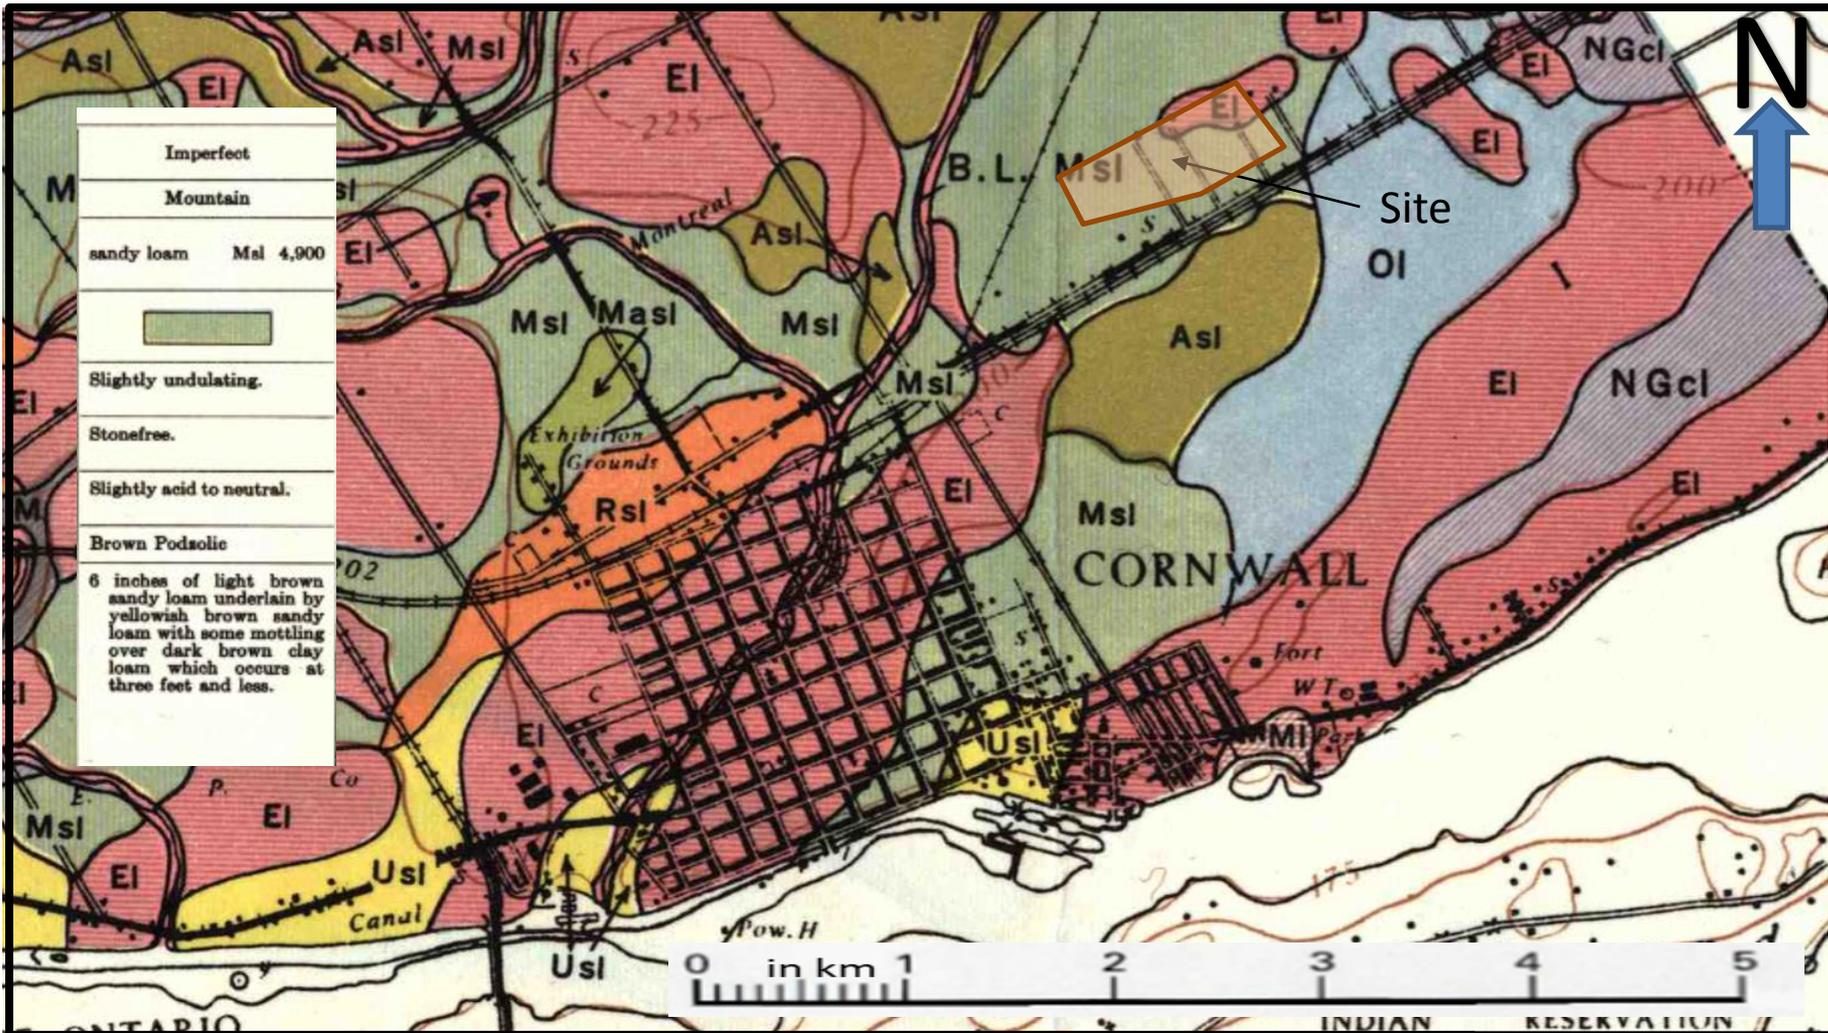
Drawing 24

Shows possible houses and school off of 10st East, Cornwall. Note Tenth Street North of Rail Road. Outwash over lacustrine. Imperfect drainage, sandy loam slightly undulating. No industry shown.

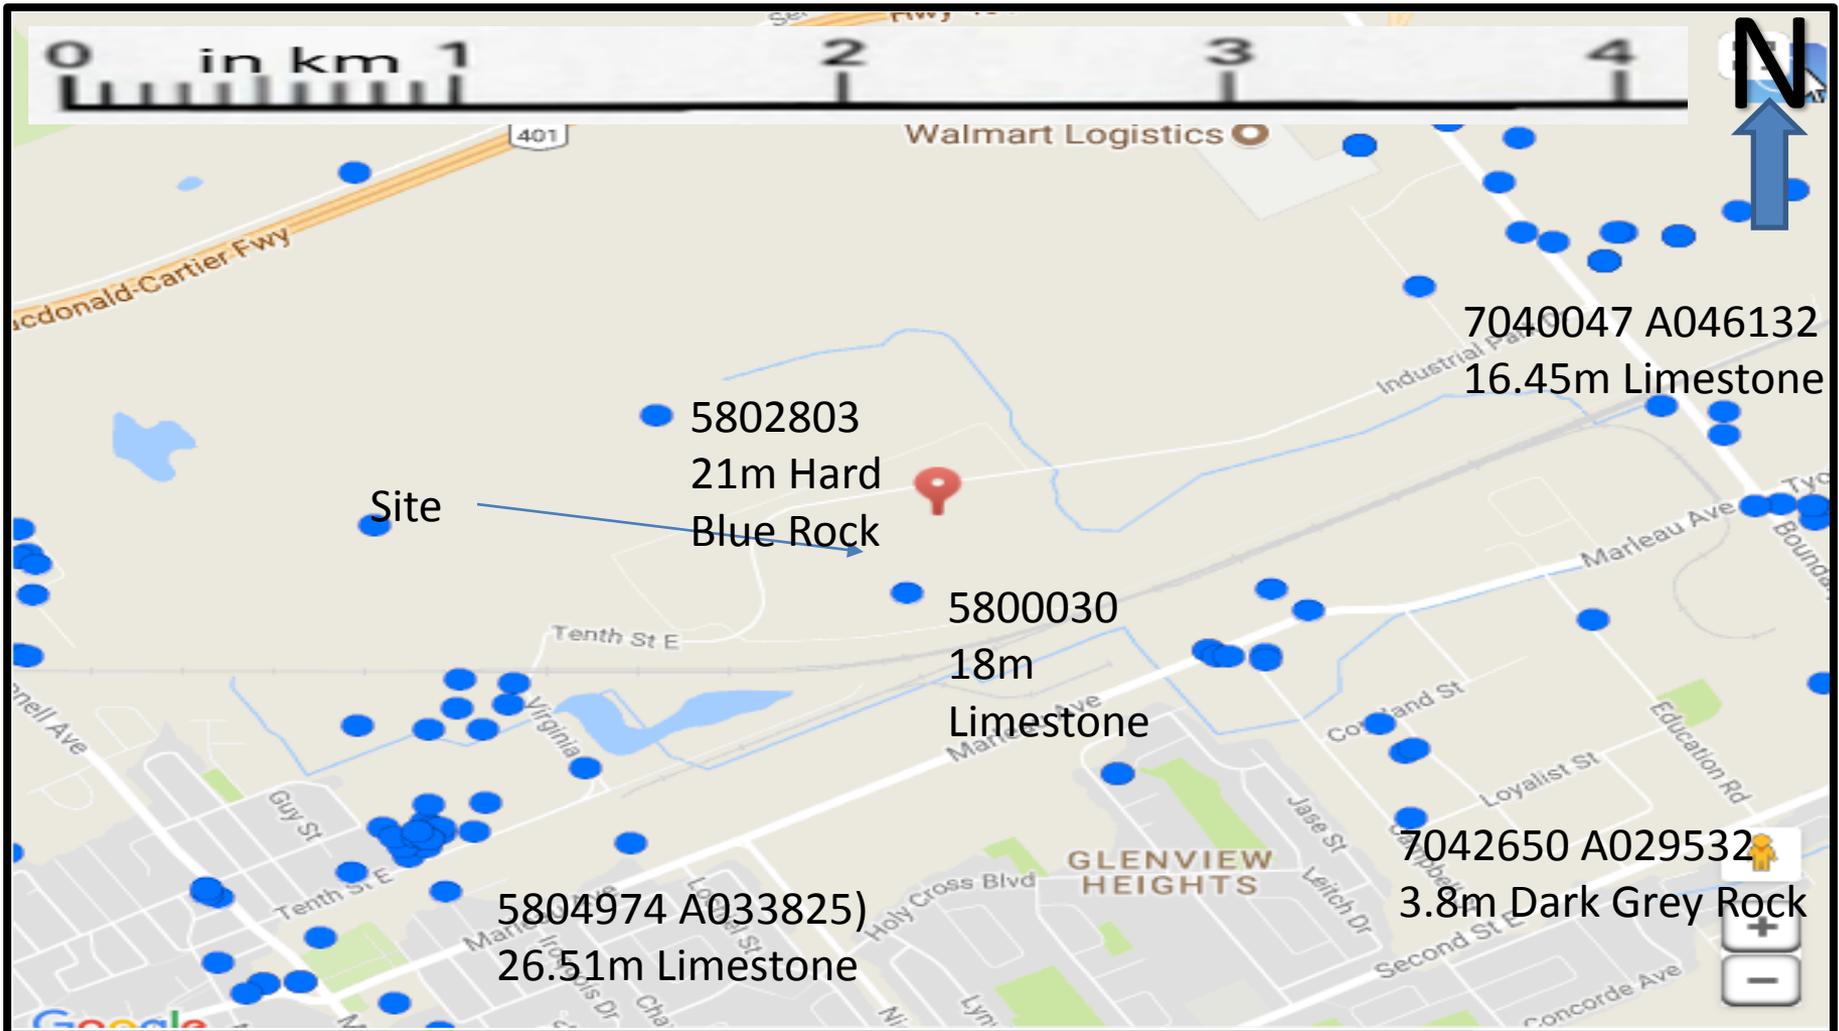
According to nearby groundwater wells the groundwater flow would seem to be south towards the Saint Lawrence River and Lake Ontario. Limestone is found in the area with clay or till as overburden. Soft clays are found in some locations. At 5800030 on site, clay was to 1.5m and then hardpan was encountered.

EAL reviewed well records (Appendix 7) and Ecolog records (Appendix 7) related to the Site. One well was noted on the POP for use with livestock in 1967 and bedrock/limestone found around 18m depth (within the EcoLog ERIS search), and 4 were within 250 meters of the POP. The soil profile in the wells was found to consist of clays, hardpan and limestone at shallow depths. It is not likely potable wells remain on the Site given the extensive site reworking. EAL found no record of the wells being decommissioned.

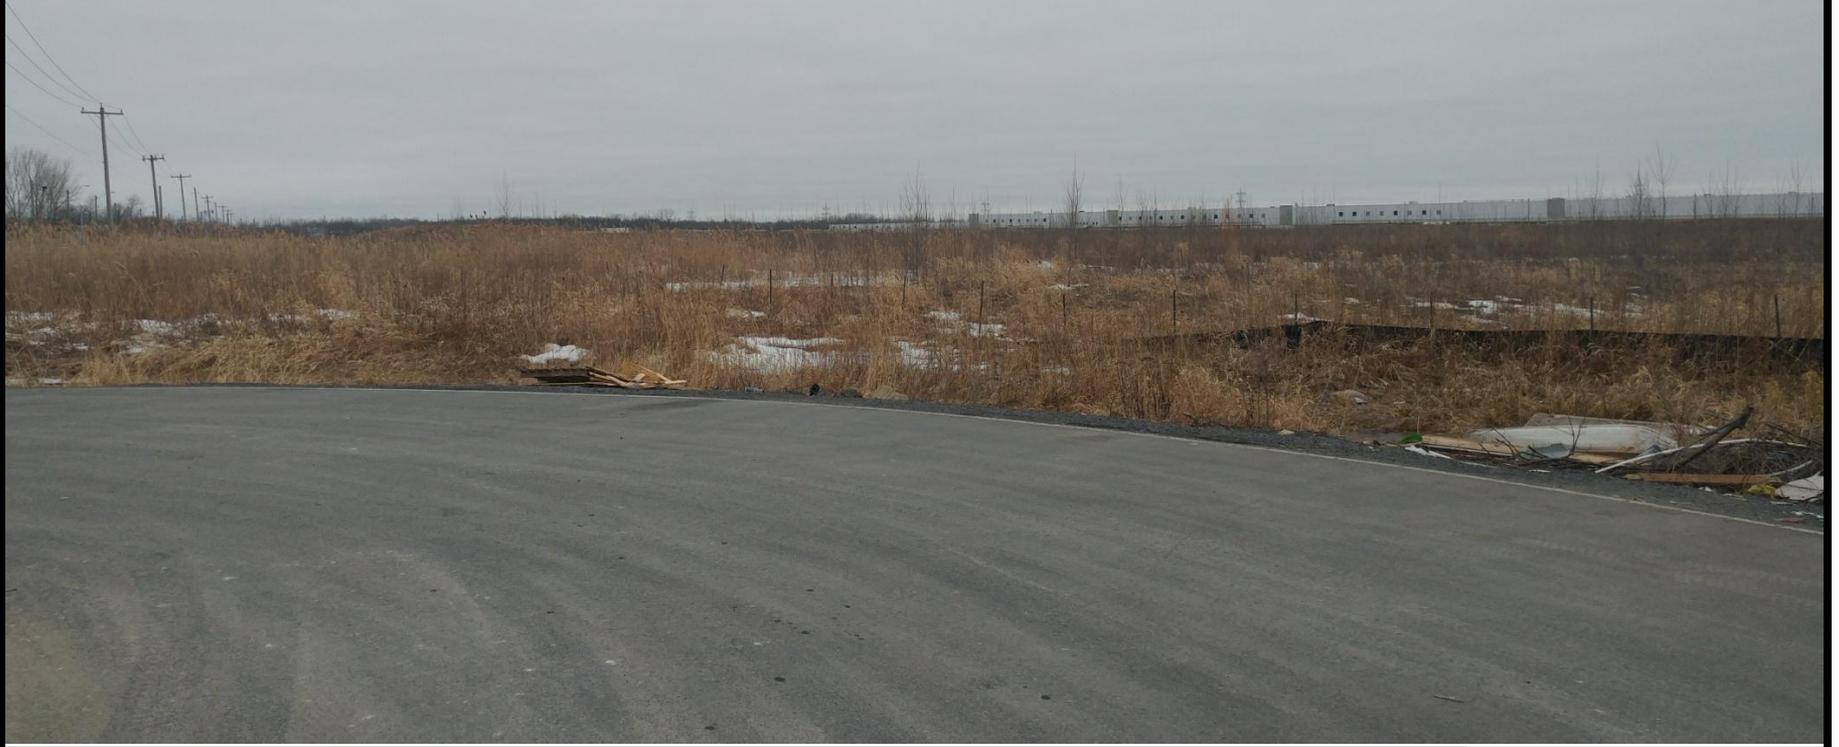
Drawing 37

Photo from Tenth Street East looking northwest. Open field. Apparent fill. Debris noted on the POP. Wal-Mart Logistics warehouse noted north of the POP.
Scale not provided

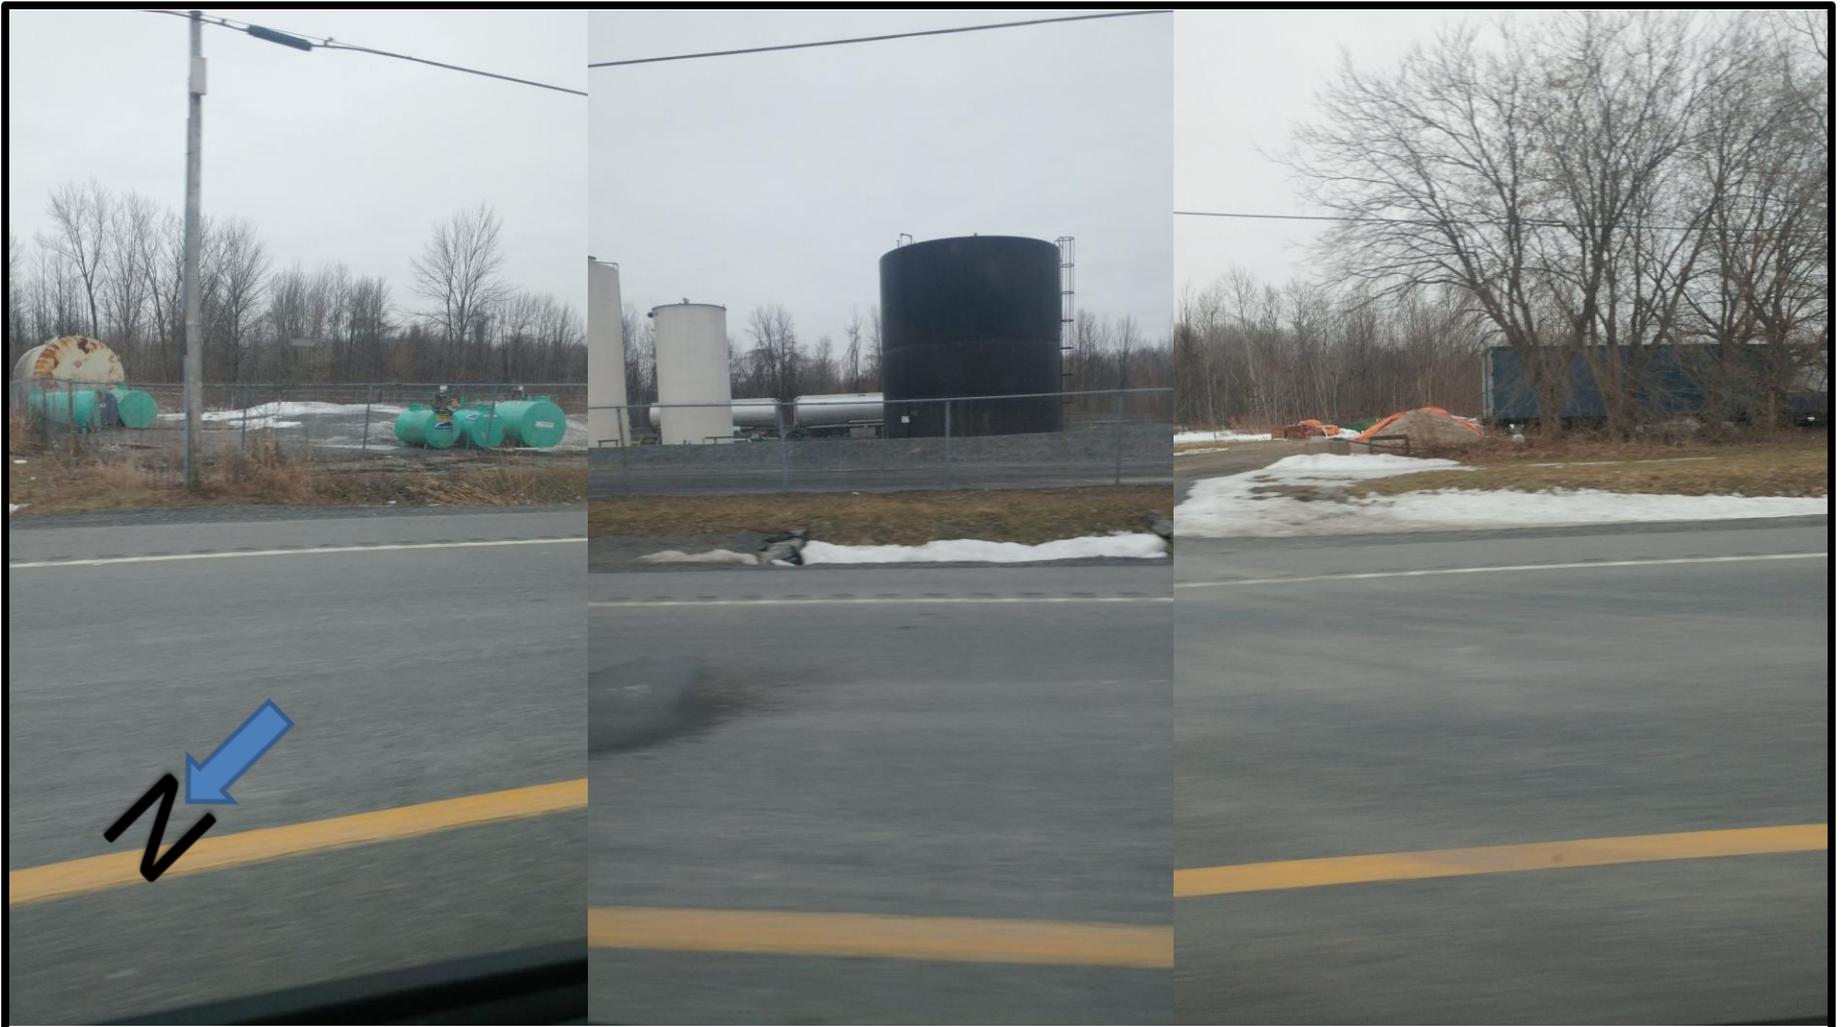
Drawing 39

Along Tenth Street East, facing south from the POP. Above ground storage tanks for fuel and storage for tractor trailers and piles of unknown scraps.
Scale Not Provided

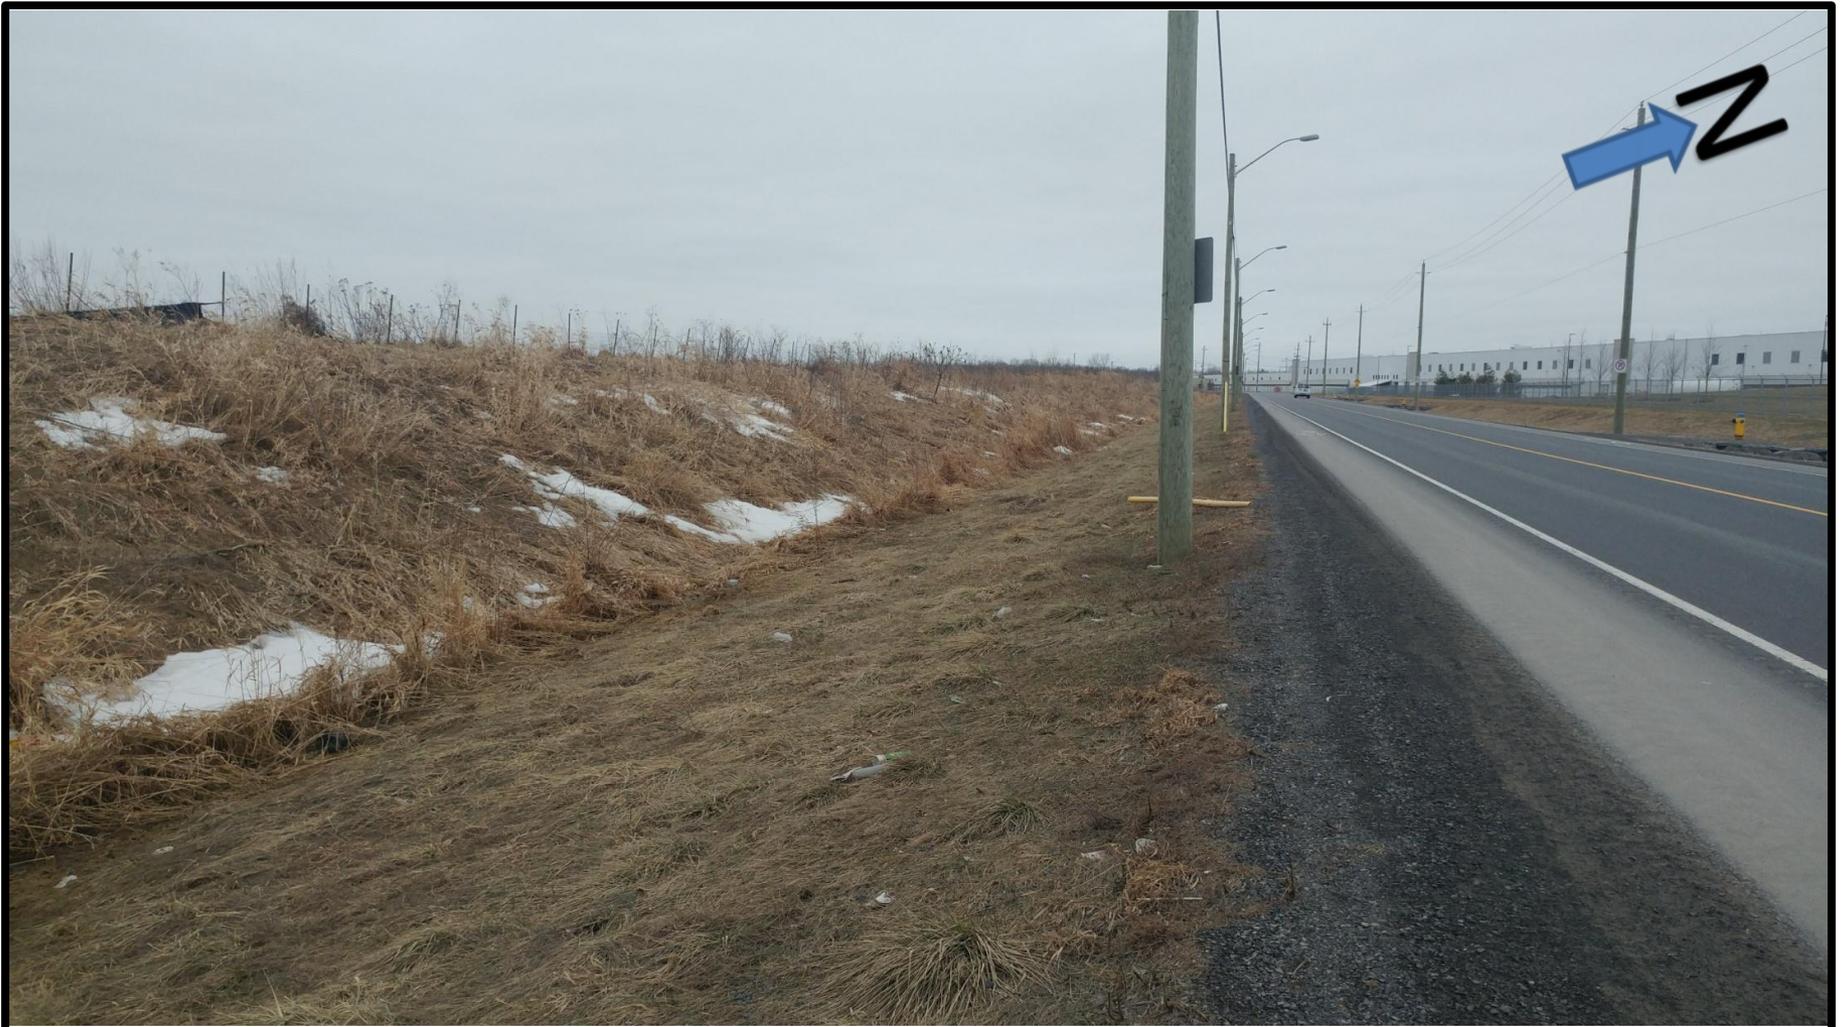
Drawing 41

Facing west from north property line of the POP on Industrial Park Drive, ditch and the warehouse shown. POP is higher elevation than the Wal-mart warehouse to the north. Note apparent 2m to 3m of fill.

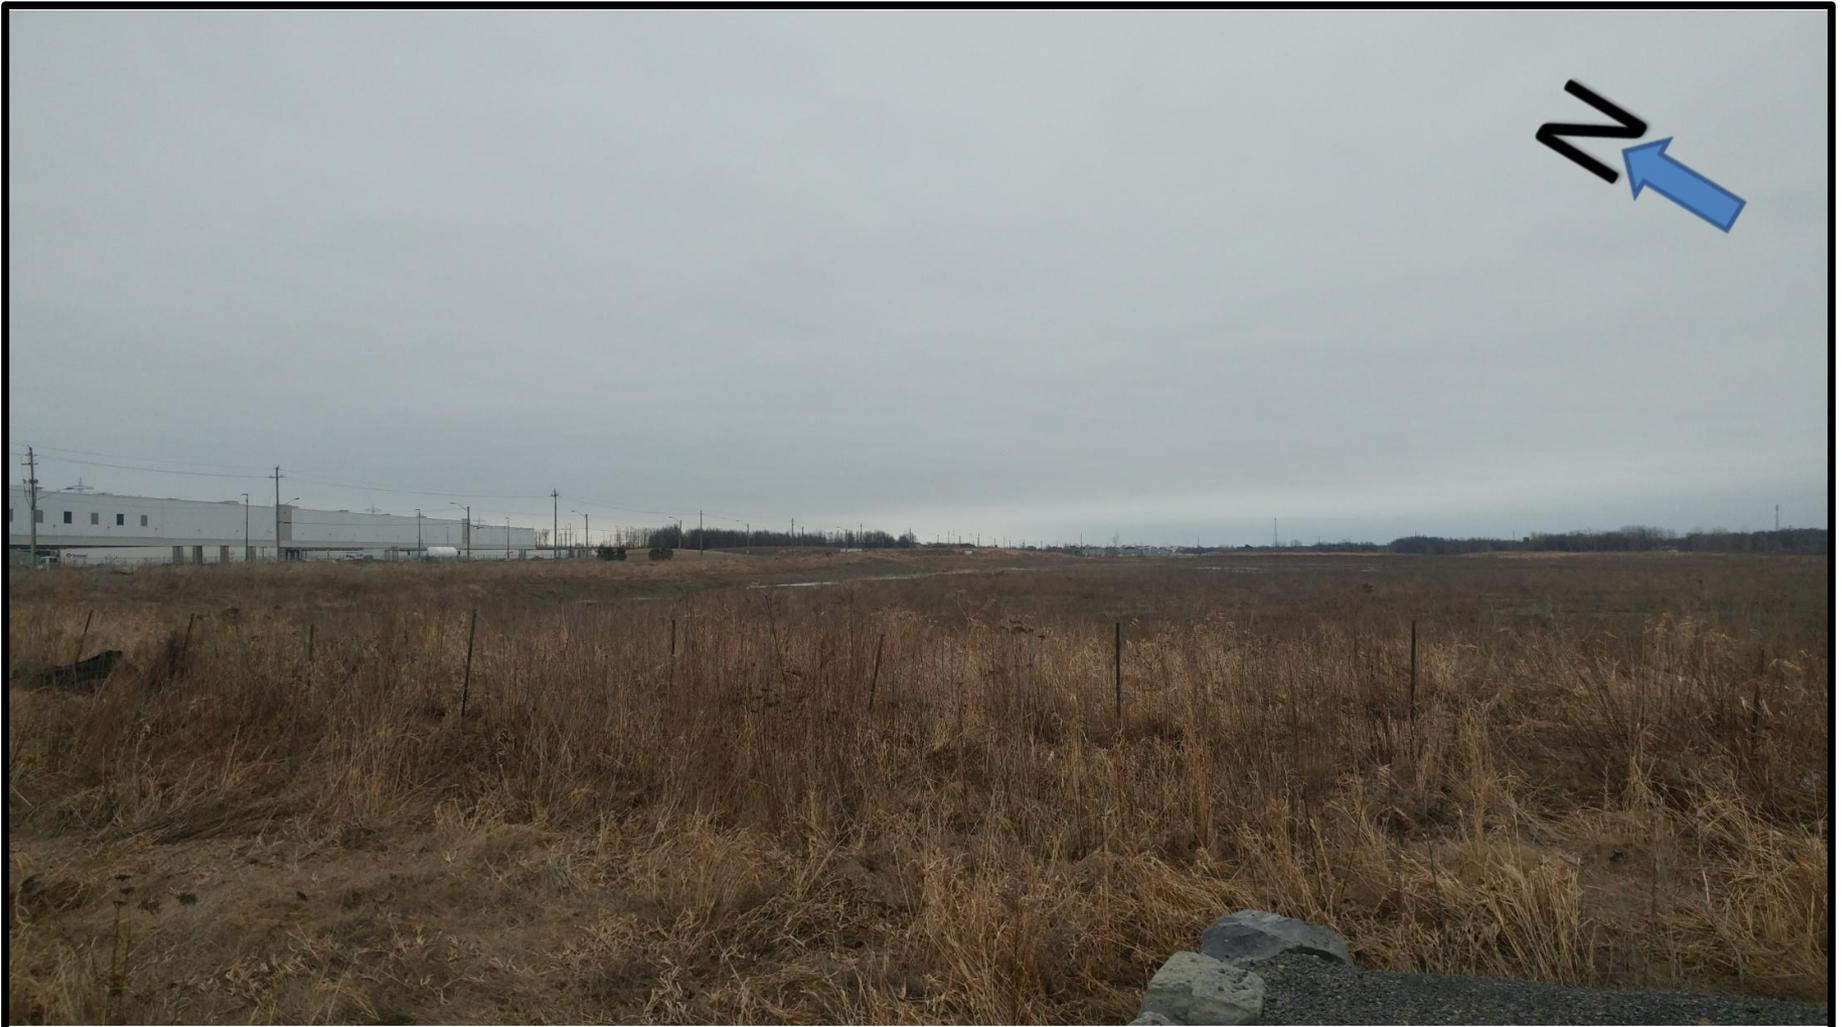
Drawing 42

Site mostly cleared, but overgrown with fill piled on the outsides of the property. Fire hydrants surrounding the POP on the road side ditches. Scale not provided.

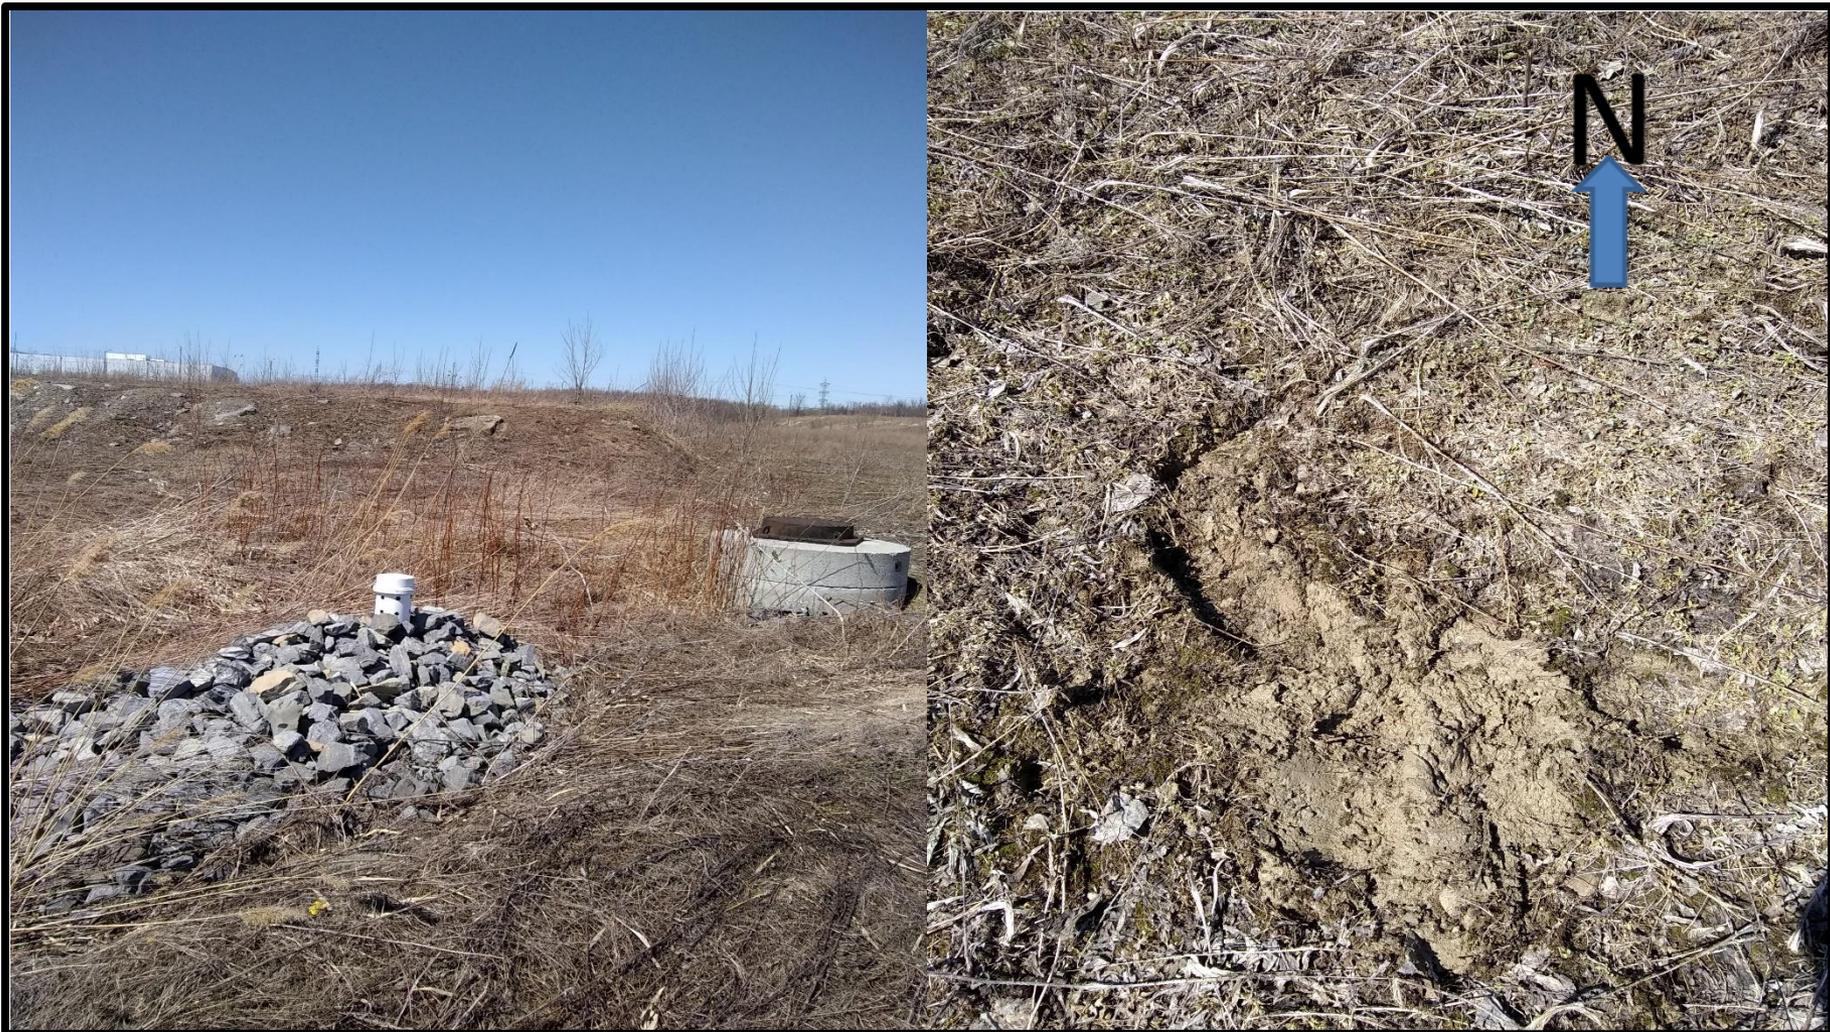
Drawing 43

Mounds of fill, catch basins for storm water system and drain for septic/sewage shown. Clayey soil with gravel throughout the area of the filled ponds. Scale not provided.

The report considers surcharging the Site (that is placing temporary fill) to cause the soft soils to settle and gain strength. The fill EAL observed on Site may be in part such a surcharge, though we have no record of this case. Neither do we have a record of the nature of the fill in the ponds.

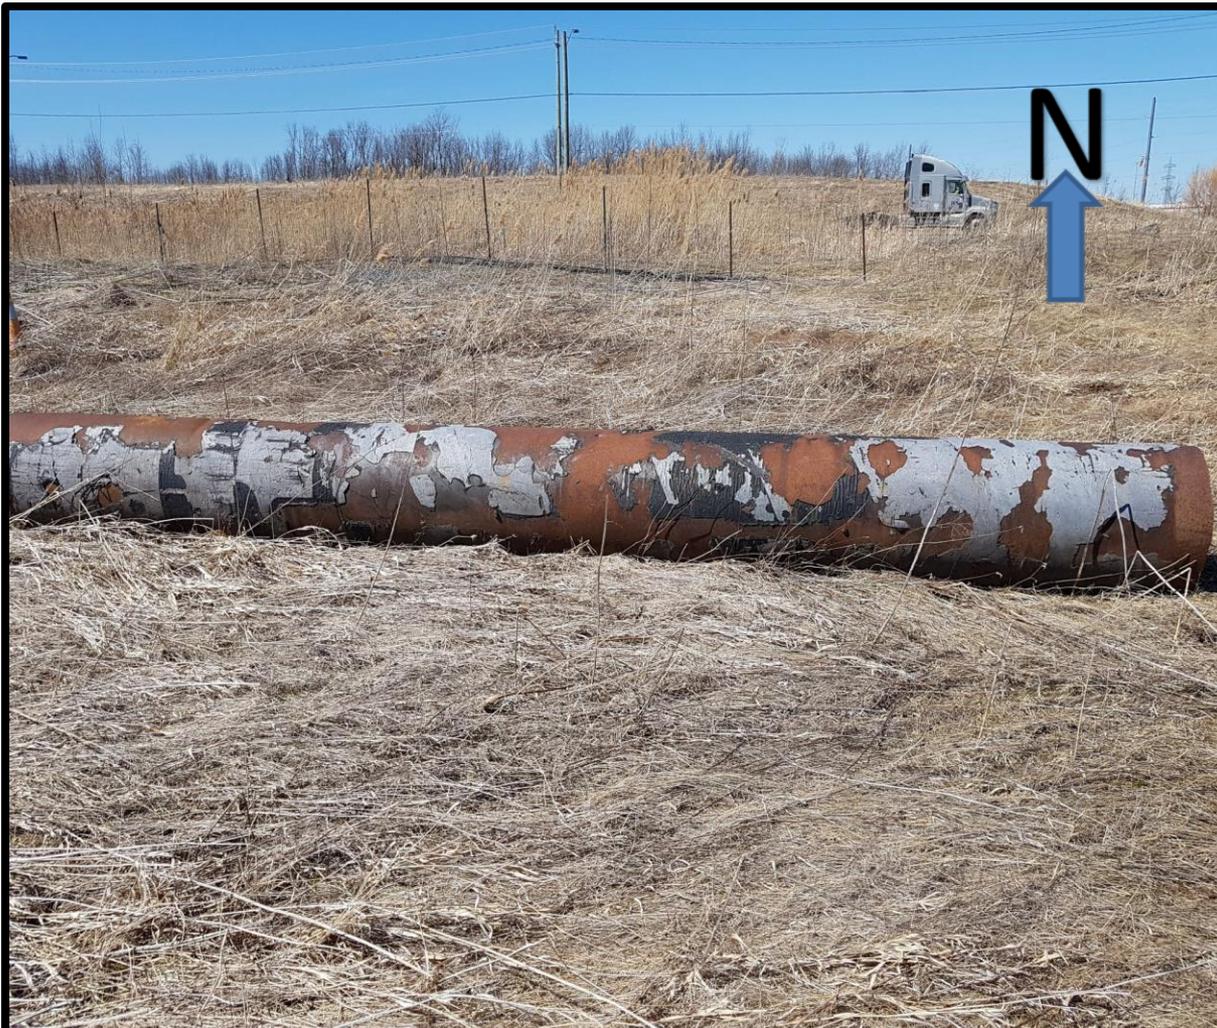
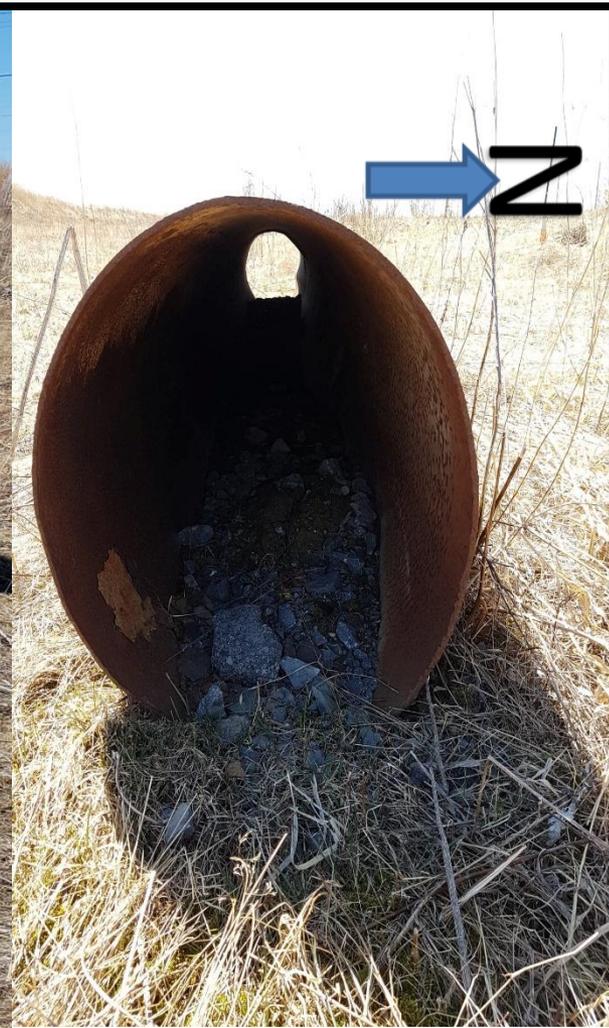
Drawing 44

Empty part of a pipeline on the northeast corner of the Site. Scale not provided.

- Records indicate Trans Northern carried out Pipeline repairs at the Site (probable NW Property line). Test holes should be considered near the active line.

The Ministry of Labour (MOL) records indicate that pipe line repairs were completed by Trans Northern, which line is adjacent to the NW corner of the Site (see Appendix 1, Appendix 6 which show pipeline on NW boundary). The repair record does not indicate if there was a spill making the repair necessary.

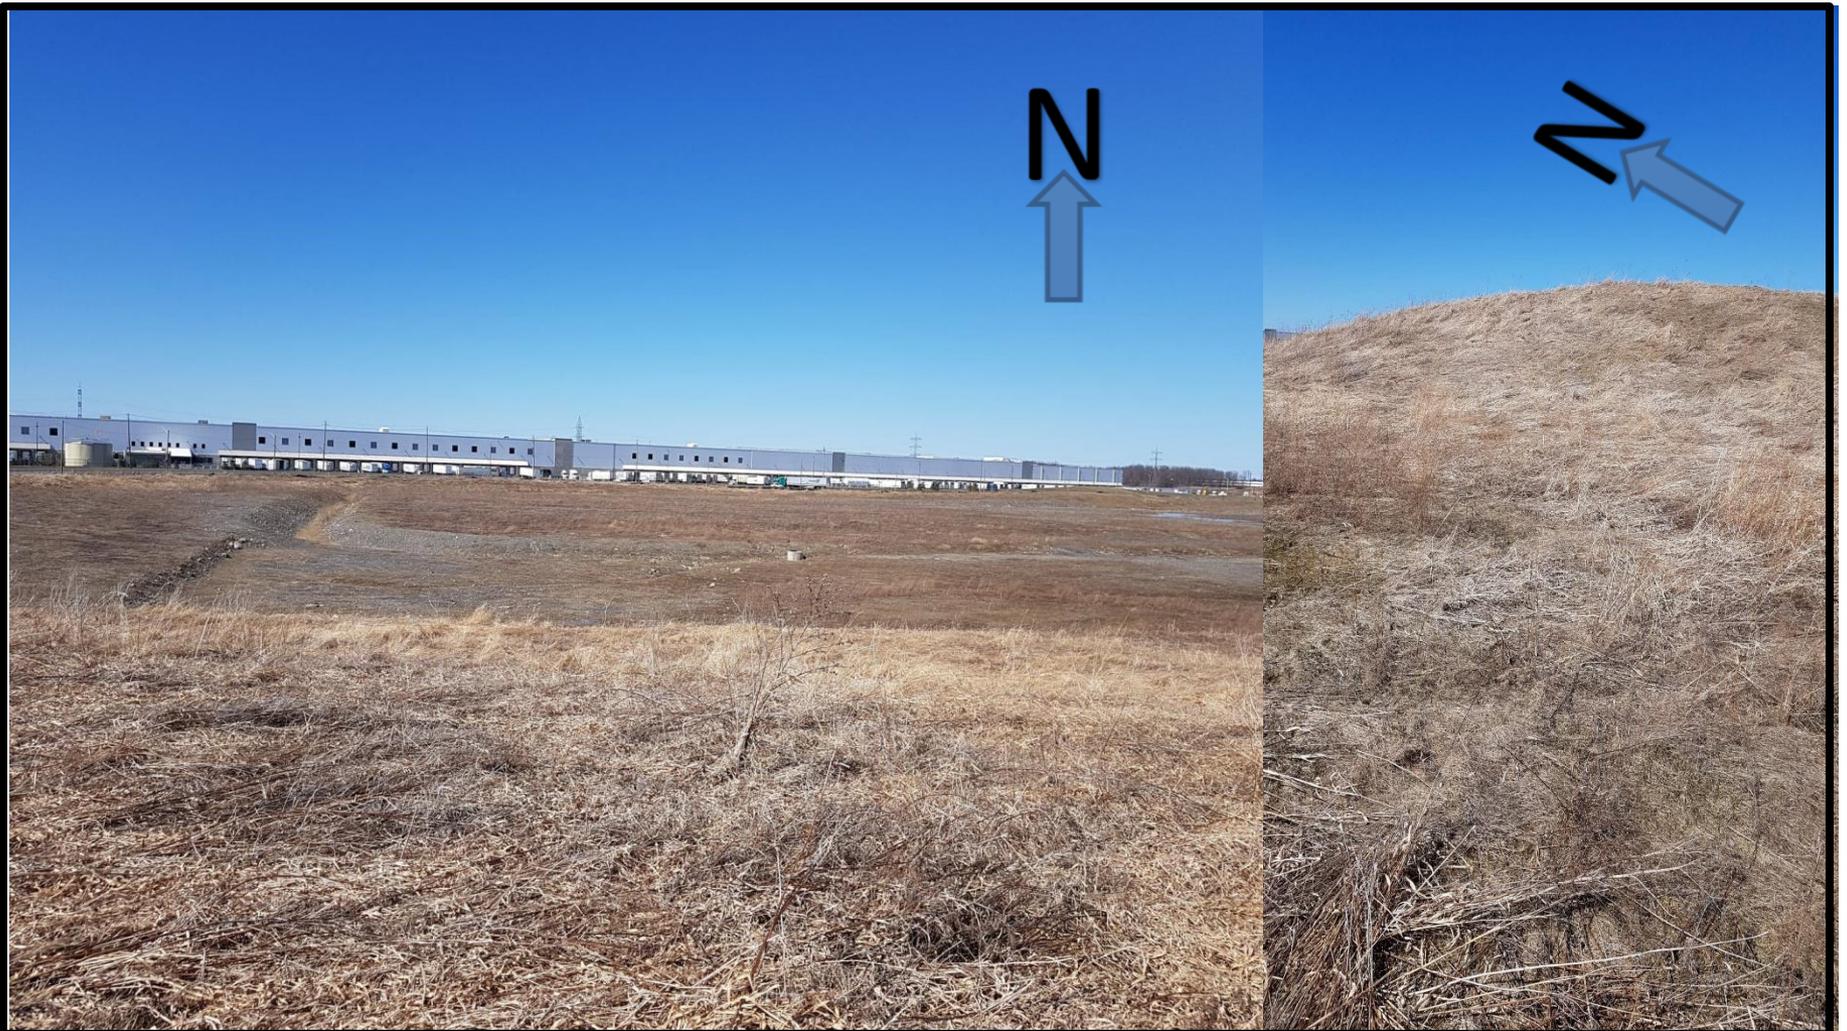
Drawing 45

Site mostly cleared, but overgrown with fill piled on the outsides of the property. Fire hydrants surrounding the POP on the road side ditches. Scale not provided.

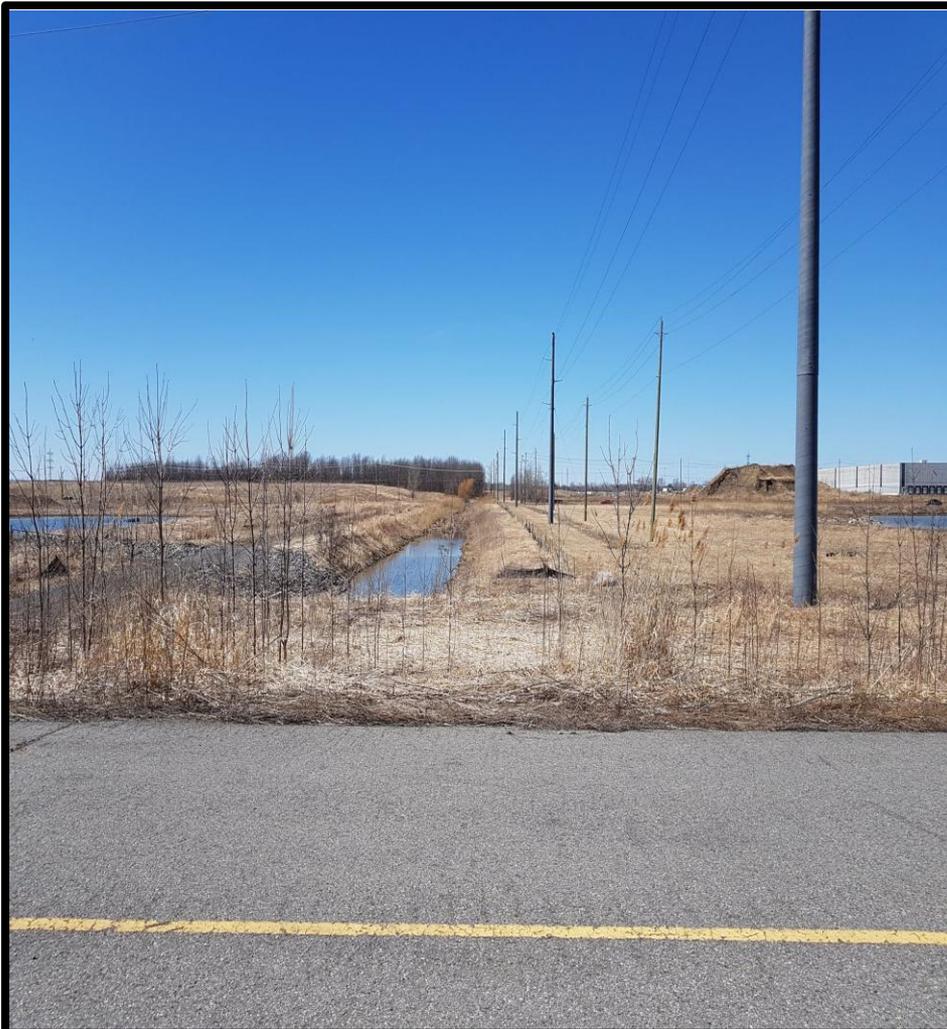
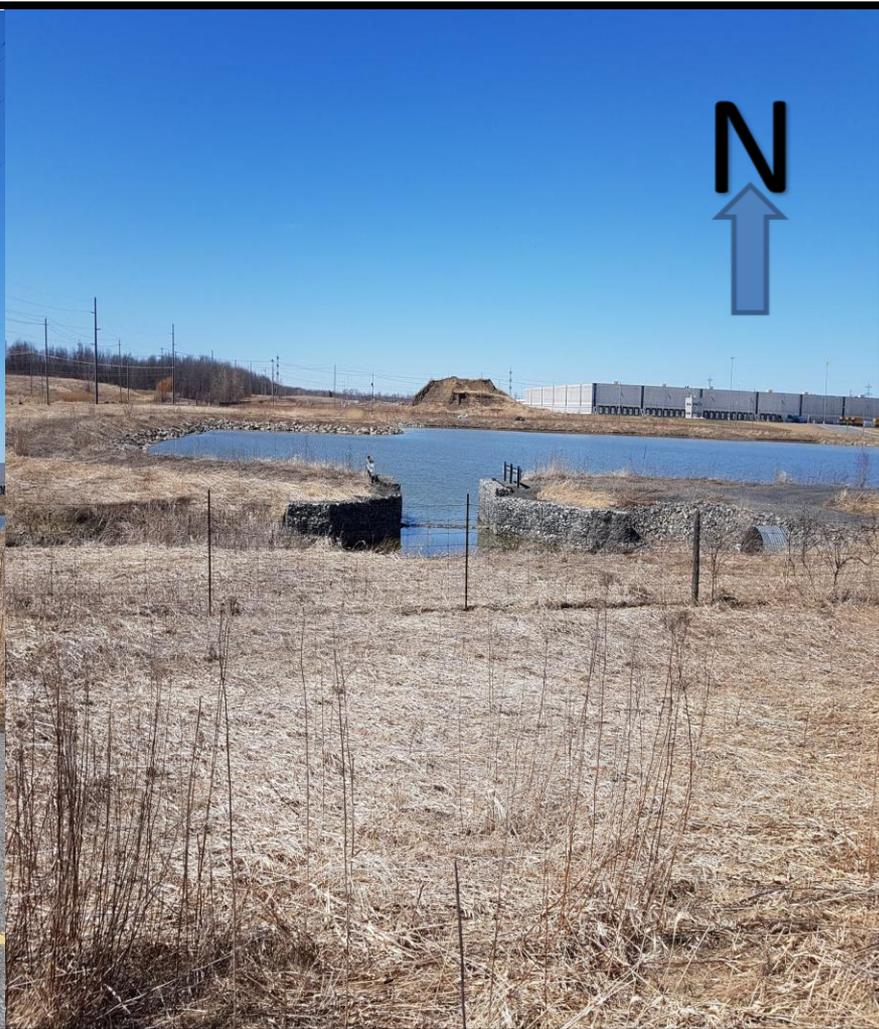
Drawing 46

Storm water pond and Donihee Drain shown; Donihee Drain is the larger pond to the east with a creek in between the two that connect them. Scale not provided.

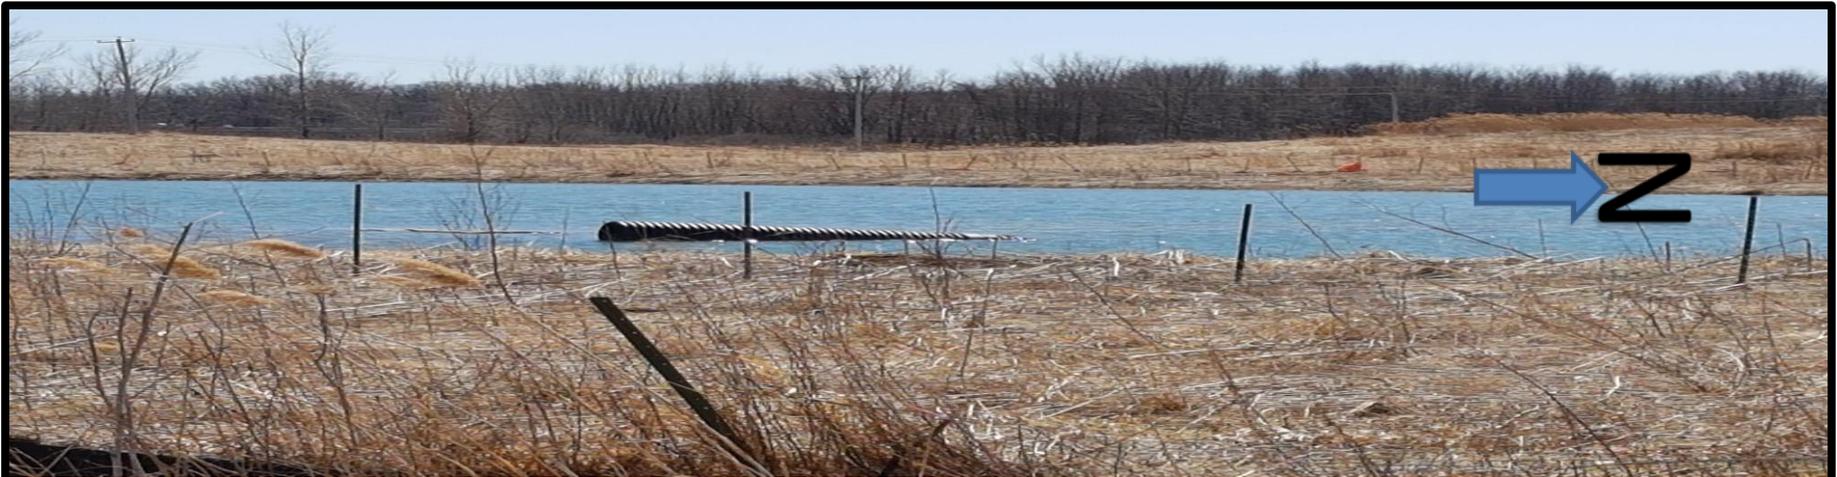
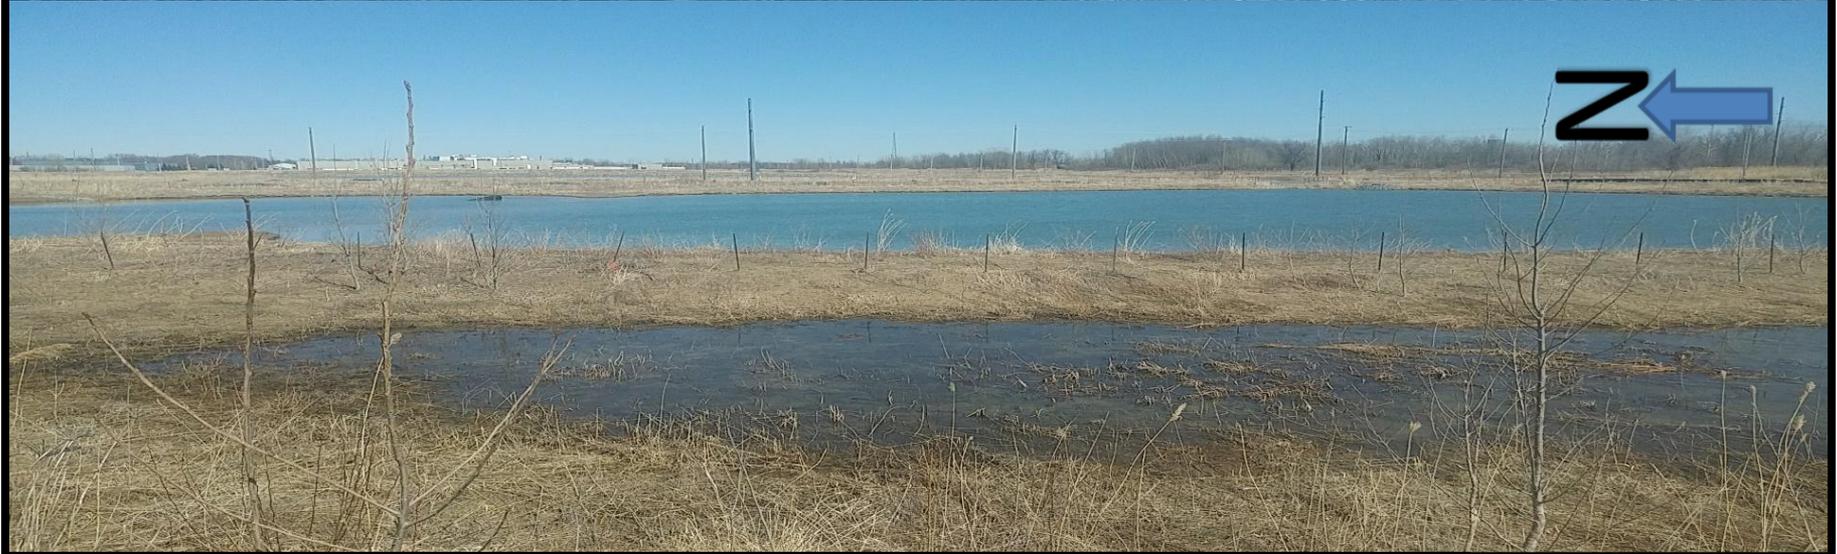
Storm water pond found on the southeast portion of the Site. Plastic pipe was floating, which could be connections to the creek that leads to the Donihee Drain. Scale not provided.
